RIPARIAN VEGETATION MONITORING
PROGRAM 1993

NECHAKO FISHERIES CONSERVATION PROGRAM
Technical Report No. RM93-7

Prepared by:
Triton Environmental Consultants Ltd.
February 2001

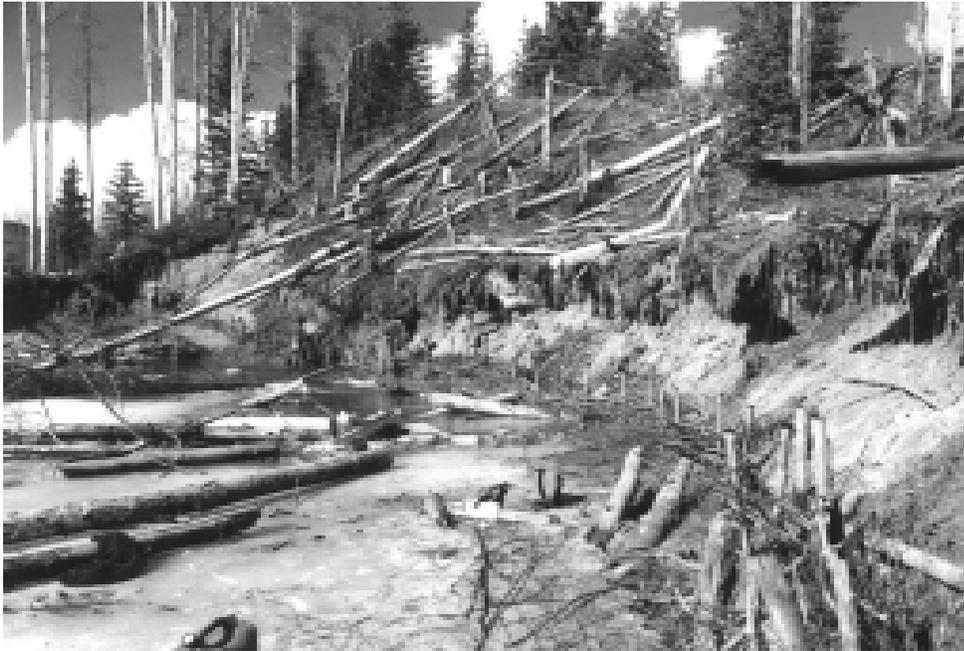
Photo 1

- PHOTO 1: Once all the live posts are positioned, slender branches are interwoven through the posts to complete the spiling. Soil is backfilled behind the spiling by collapsing the bank behind the structure.

Weathies were comprised primarily of alder and Bebbs willow. Longer branches were more suitable since they encompassed more posts, making the structure stronger. Once the weaving of weathies between posts was completed, the bank was collapsed behind the spiling, and soil was backfilled to the top of the weaving (Photo 1).

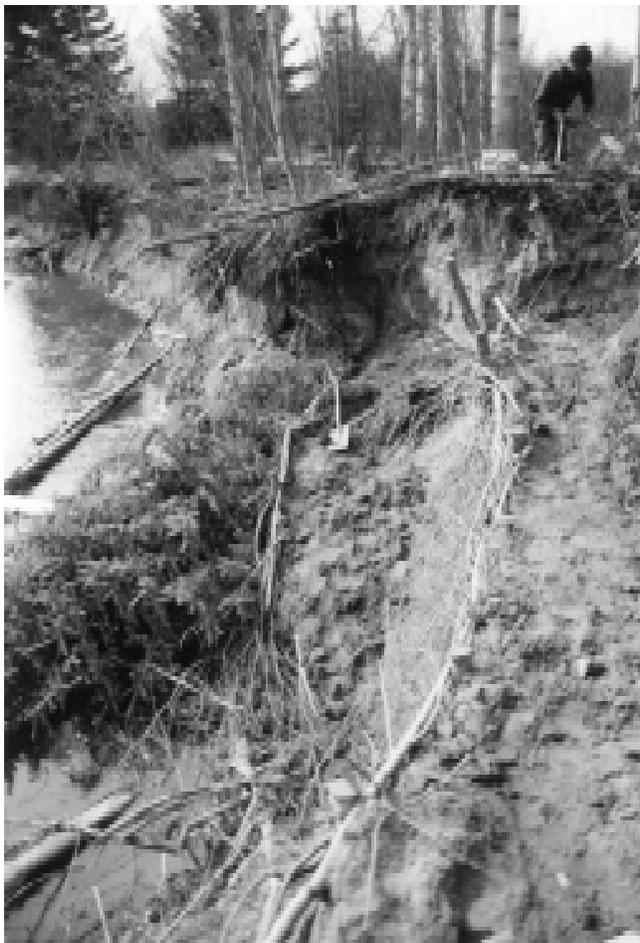
Photo 2

- PHOTO 2: Two small spruce tree revetments, anchored by 1/4" cable to a nearby cottonwood, were woven into this short section at the upstream end of the spiling.

vent undermining at the upstream end of the main structure since it was expected that the upstream end of the spiling would bear the brunt of increased water current. Two small spruce tree revetments, anchored by 1/4" cable to a nearby cottonwood, were woven into this short section of spiling (Photo 2).

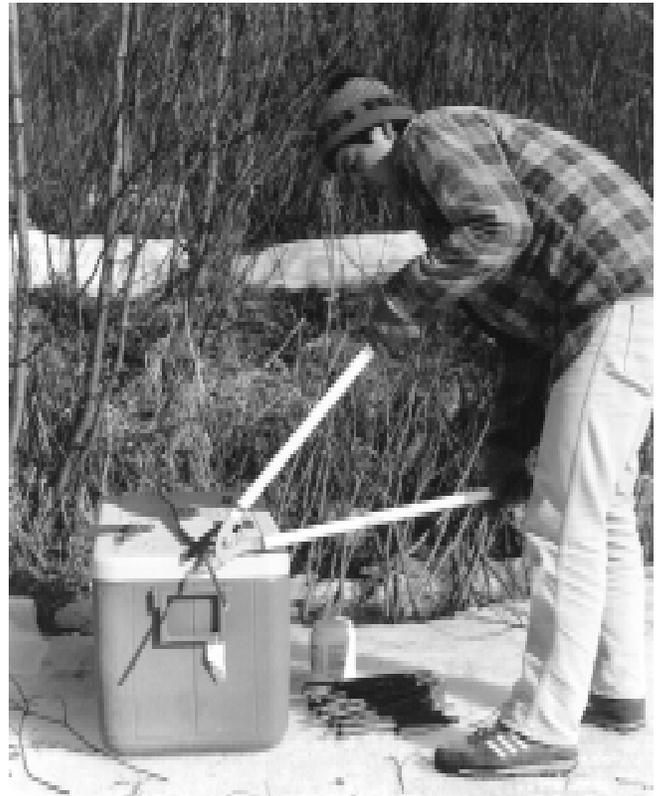
Photo 3

- PHOTO 3: Prior to planting rooted cuttings, donor material was collected from near the Greer Creek test site. Cuttings were stored on snow in a cooler, and transferred to the Deadman Creek coldframes.

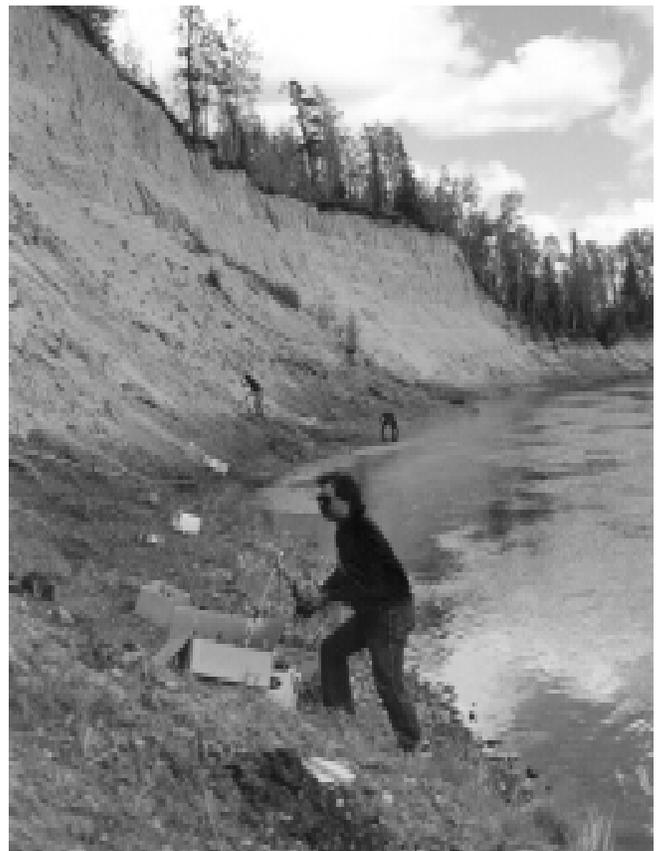
Photo 4

- PHOTO 4: The area planted with rooted cuttings extended approximately 150 m down stream from the upstream end of the clay bank.
- PHOTO 5: The brush mattress was comprised of young alders and Bebb's willow branches. These were secured with trembling aspen (*Populus tremuloides*) poles positioned as cross braces and anchored with stakes and wire.

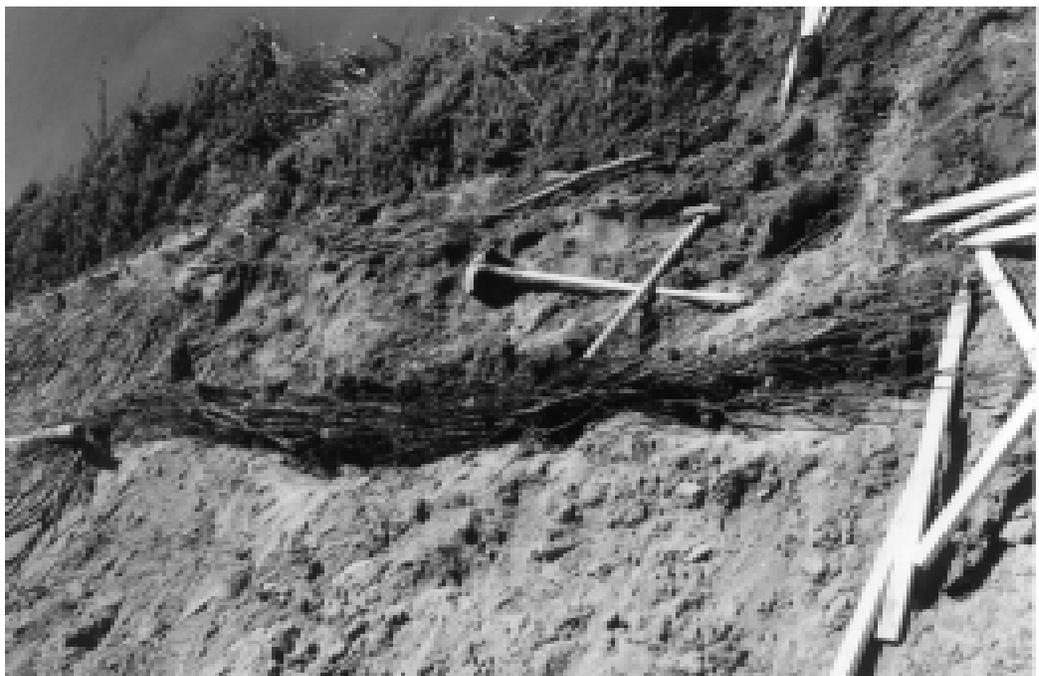
Photo 6

- PHOTO 6: Upstream of and adjacent to the brush mattress a total of four wattles were placed in four separate trenches which ranged from 1 m to 5 m up from the stream edge.

Upstream of, and adjacent to, the brush mattress, a small section of contour wattling was constructed (Photo 6). A total of four wattles were placed in four separate trenches which ranged from 1 m to 5 m up from the stream edge. Each wattle was secured with 1 m stakes driven into the bank. An area of bank, approximately 15 m², was planted in this fashion.

devoid of needles. The contour wattling showed signs of degradation as wattles were becoming exposed. This suggests that the wattles were not sufficiently buried when initially placed or that they had become exposed by erosion. The short sections of wattling covered by contour wattling, one wattle long by three wattles high, may also have adversely affected this section's stability. Longer sections of contour wattling may be less prone to exposure or downslope move-

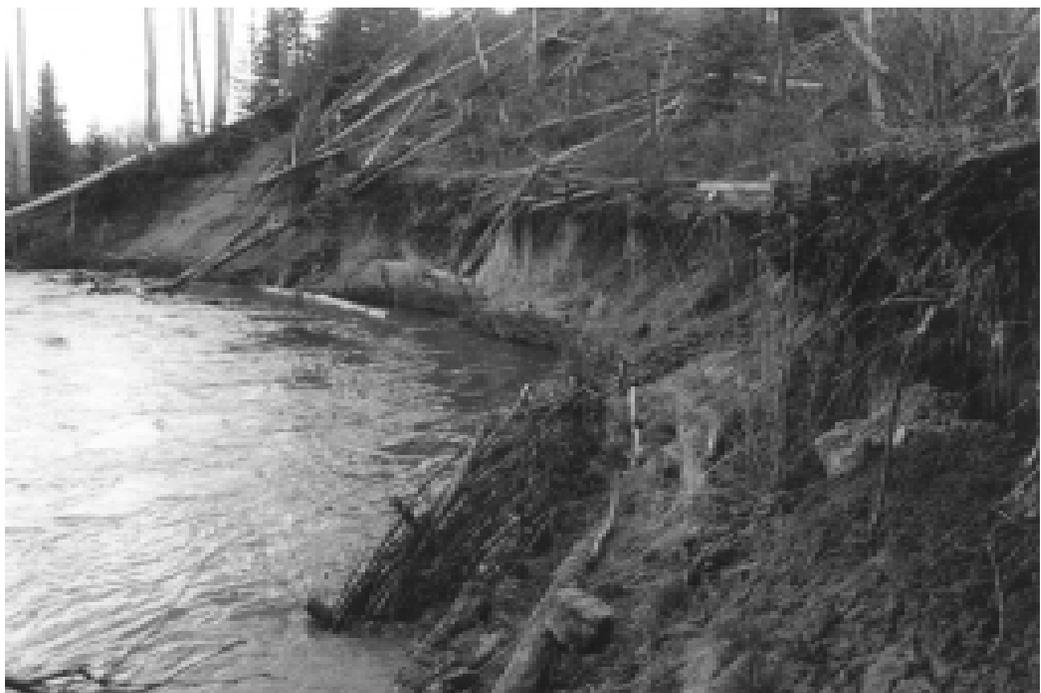
Photo 7

- PHOTO 7: Unraveling at the downstream end of the Greer Creek spiling was quite pronounced by May 1993.
- PHOTO 8: As a result of the June 1993 flood, the first 30 meters of spiling were almost completely buried by sediment, and the course of Greer Creek was changed away from the test site.

The spiling at the Greer Creek test bank, although still intact, had begun to unravel at its downstream end by the end of the monitoring program. This unraveling was initially observed in 1992 but was more pronounced in May 1993 (Photo 7). A rain-generated flood event, which occurred during the week of June 28, 1993, resulted in a complete change in channel morphology at the Greer Creek revegetation site (Figure 7). The discharge for Greer Creek during this flood was approximately twice that estimated during freshet conditions in May 1993. And, although no gauging station exists for Greer Creek, comparison to recorded freshet values and conversations with local landowners suggested it was an extreme event. As a result of the June 1993 flood, the first 30 meters of spiling were almost completely buried by sediment (Photo 8). The next 10 m of spiling were partially buried, while the remaining 10 m of spiling were still totally exposed.

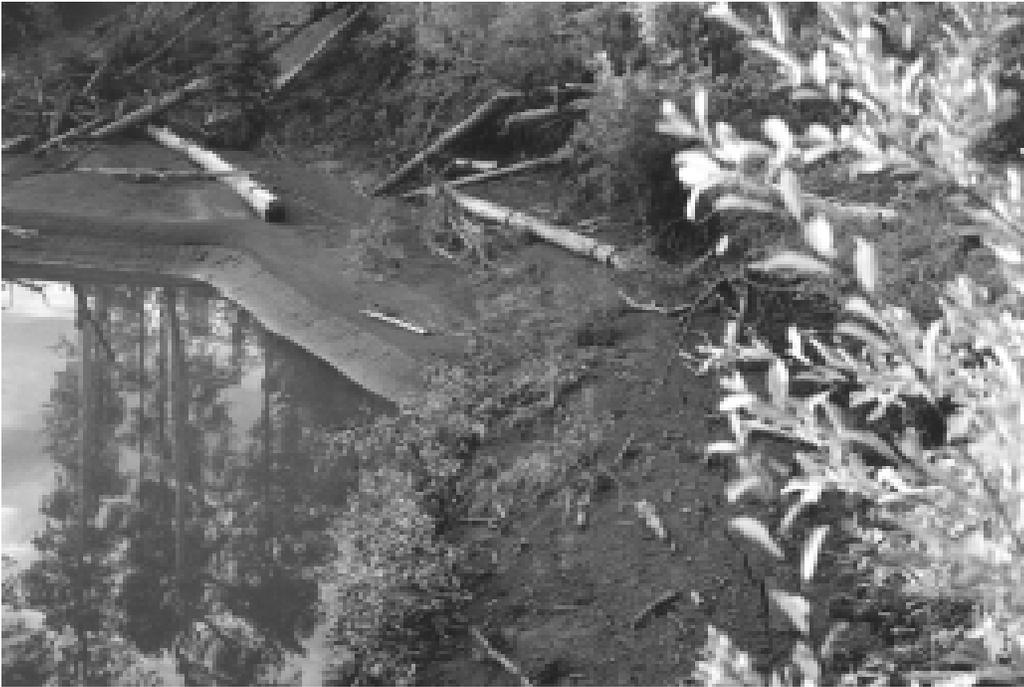
Photo 8

The change in channel course isolated the spiling away from the new stream channel so that the spiling, which was adjacent Greer Creek, was left 25 m west of the active channel. An estimated 30 m³ of material was de-

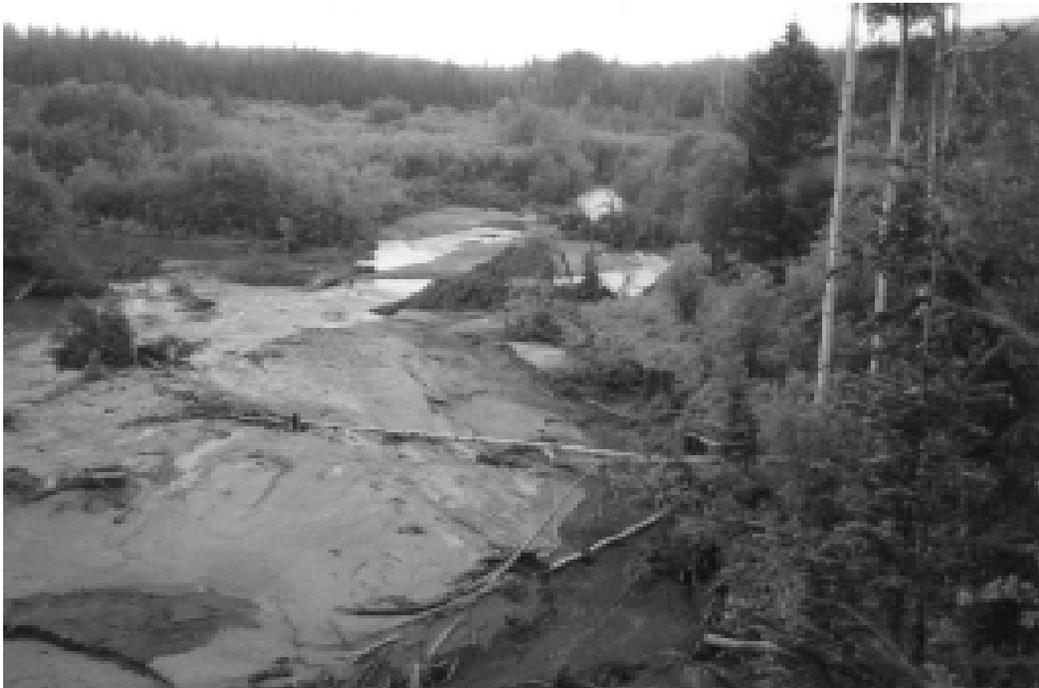
Photo 9

- PHOTO 9: An estimated 30 m³ of material was deposited between the spiling and the new river channel

posited between the spiling and the new river channel (Photo 9). The final assessment, conducted in November 1993, assessed vegetative growth over the project period. However, the isolation of the site due to the channel shift resulted in termination of the pilot test and no assessments other than opportunistic ones were made of the growth of the planted materials.
