**IN-STREAM HABITAT COMPLEXING
1993-1995
-PILOT TESTING-**

NECHAKO FISHERIES CONSERVATION PROGRAM
Technical Report No. RM95-3

Prepared by:
Triton Environmental Consultants Ltd.
January 2003

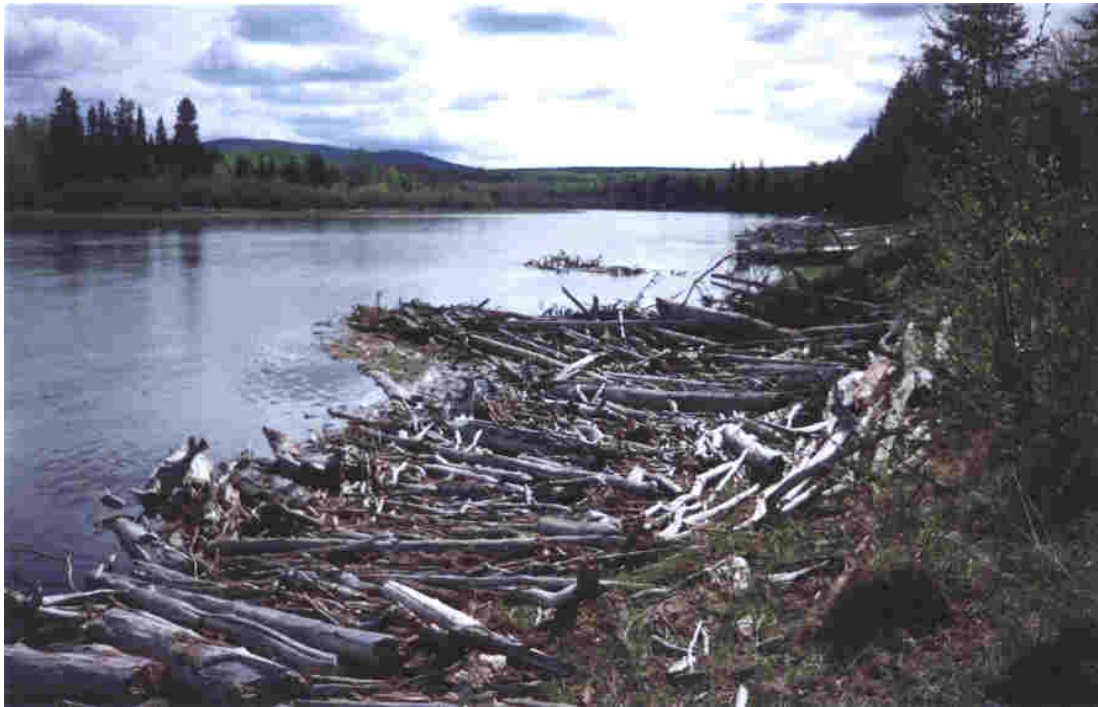
Photograph 1: Stable rootwad sweeper (RM24.35RS) providing 55 m² of cover area (May 1995).

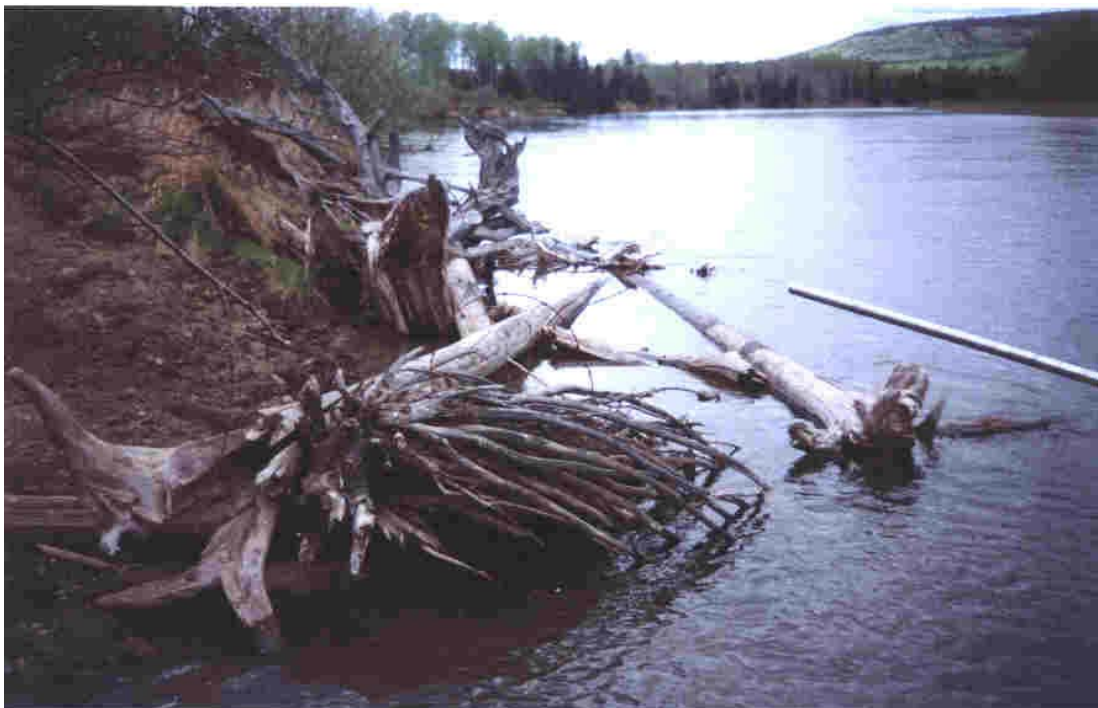
Photograph 2: Brushpile (RM31.4BP) with little cover area due to mobile river bank (May 1995).

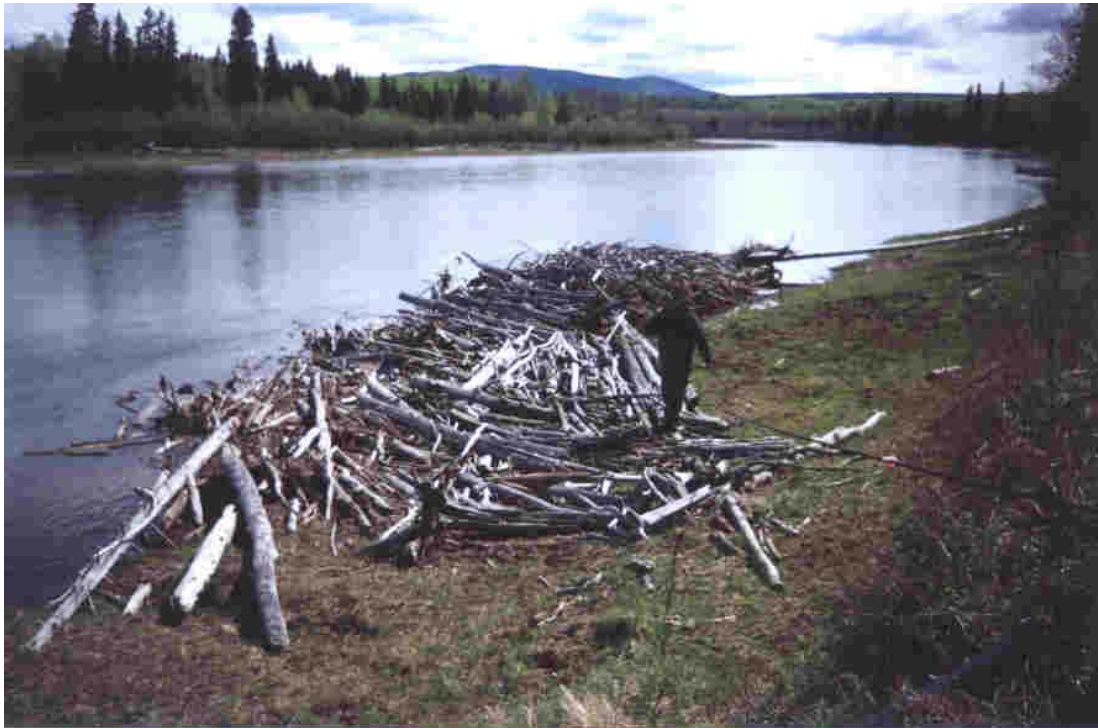
Photograph 3: Stable floating crib (RM24.4FC) showing large cover area of 91 m² (May 1995).

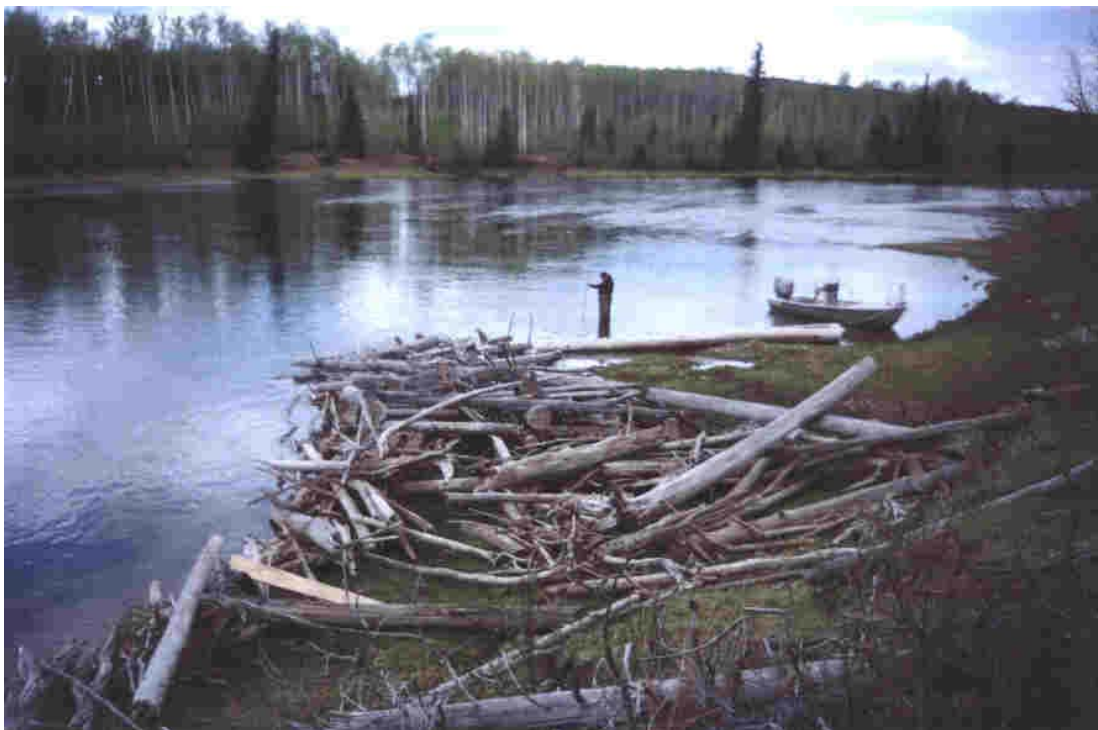
Photograph 4: Floating crib (RM27.4FC) not providing much cover as its upstream end pushed onto the shore (May 1995).

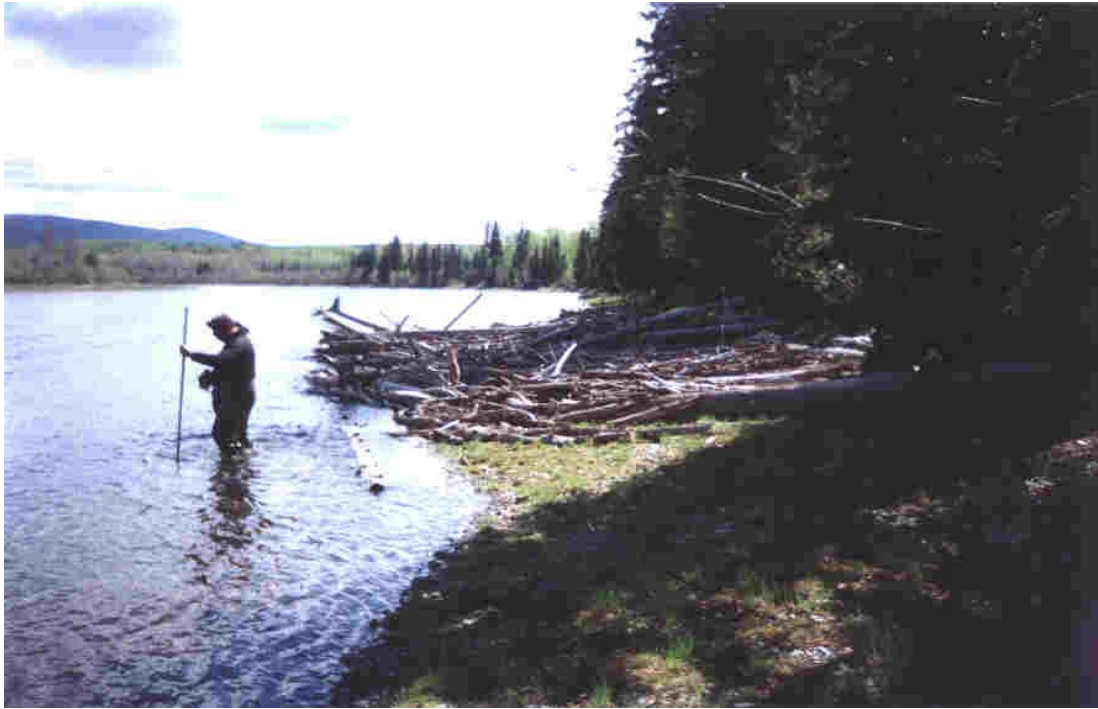
Photograph 5: Pseudo beaver lodge (RM24.6PBL) still retaining debris, providing 50 m² of cover area (May 1995).

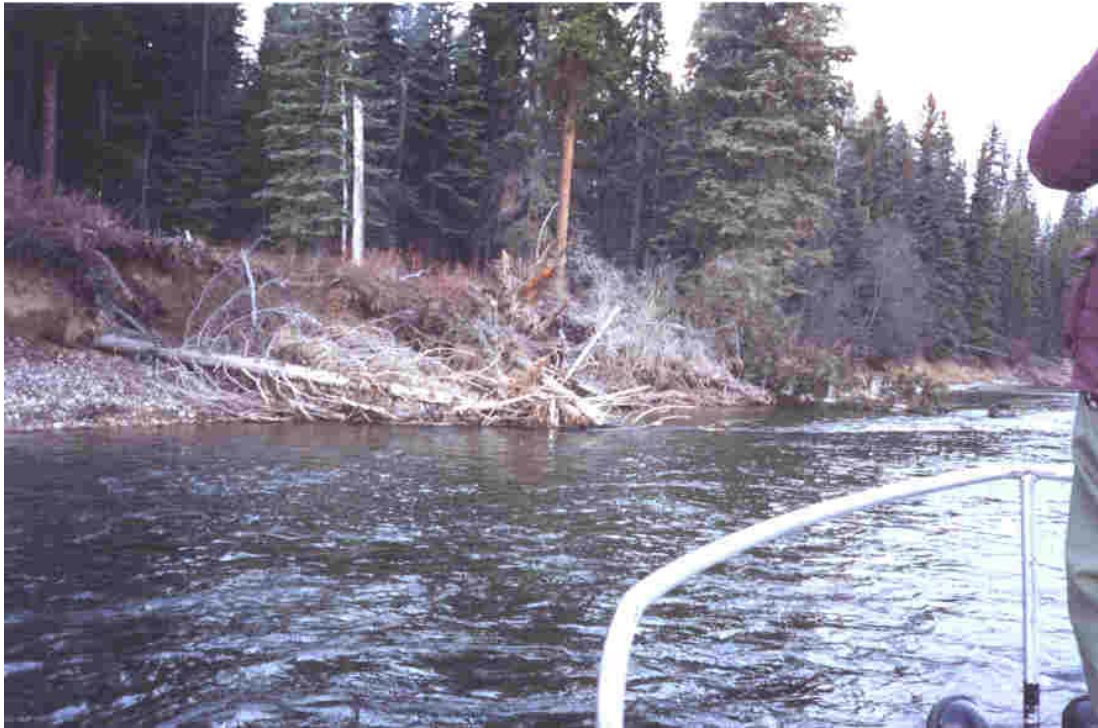
Photograph 7: Downstream boom added to rail anchored sweeper (LM82.1RAS) to improve debris capture (November 1993).

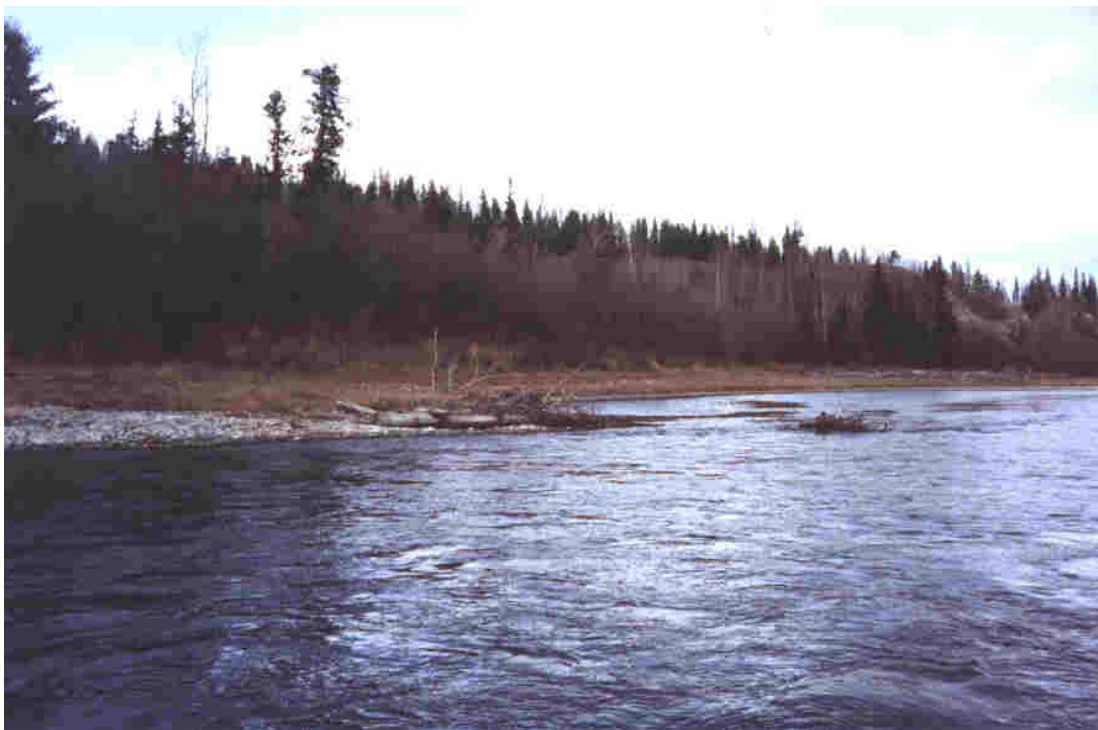
Photograph 8: Rail-anchored sweeper (LM29.4RAS) broken in half, stripped of majority of branches and not providing much cover area (November 1993).

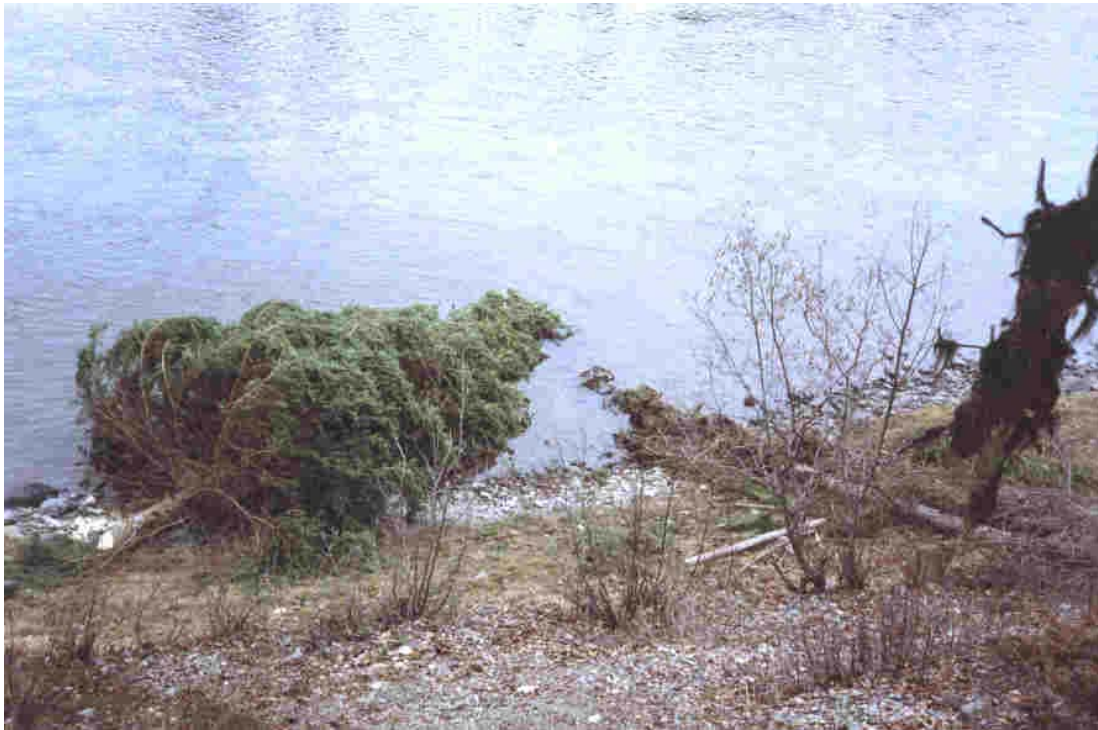
Photograph 9: Downstream boom added to hand-placed anchored sweeper (LM75.9HAS) to improve debris capture (April 1993).

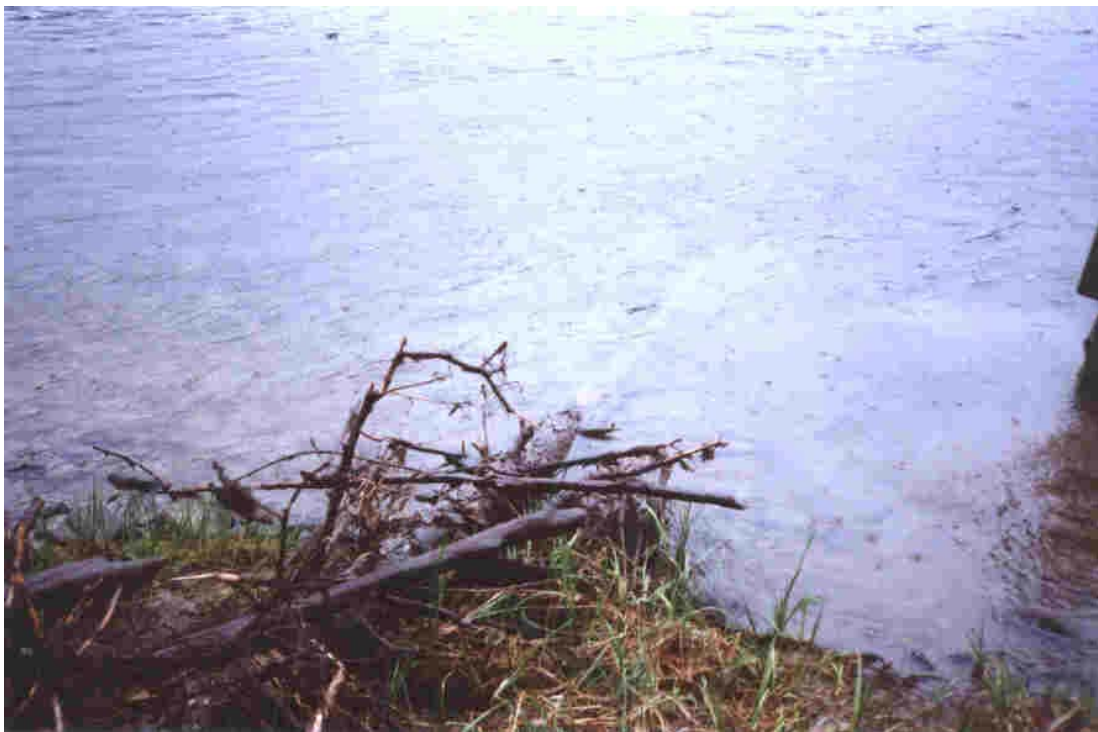
- Rail-anchored sweepers RM22.1RAS and RM26.9RAS were stripped of their branches and the tree at RM22.95RAS was broken.
- Similarly, hand-placed anchored sweepers RM74.1HAS and LM80.2HAS were stripped of their branches and the tree at LM73.0HAS was broken.

Photograph 10: Hand-place anchored sweeper (RM74.1HAS) reduced to bare log due to ice and summer flows. Removed from physical assessment in 1995 (May 1994).

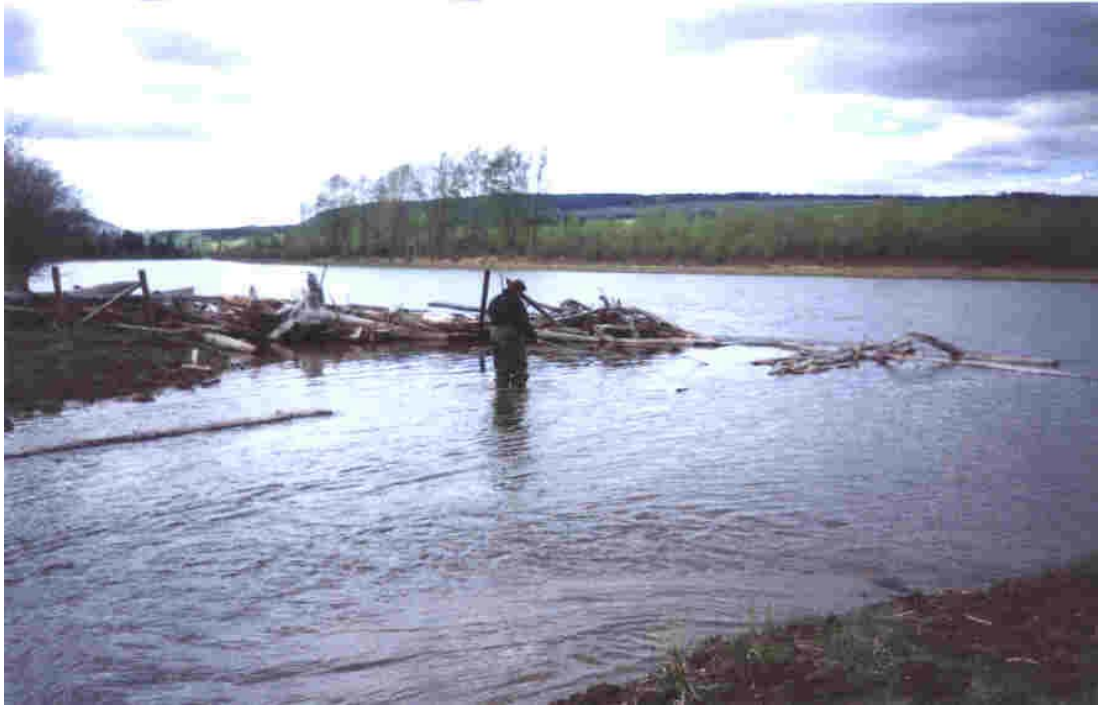
The cover areas of the two pipe-pile debris catchers were smaller than in 1994, having been reduced from 91 and 192 m² to 42 and 149 m². The smaller complex lost a significant amount of debris as its downstream pile finally broke after several years of uplift and loosening during winter. No displacement was observed to the other complex although sediment continued to accumulate immediately downstream of the structure. The substrate generally consisted of fines and gravel. No recommendations were made for any repairs.

Photograph 11: Smaller pipe-pile debris catcher (RM34.7PDC) providing 42 m² of cover area despite loss of downstream pile (May 1995).

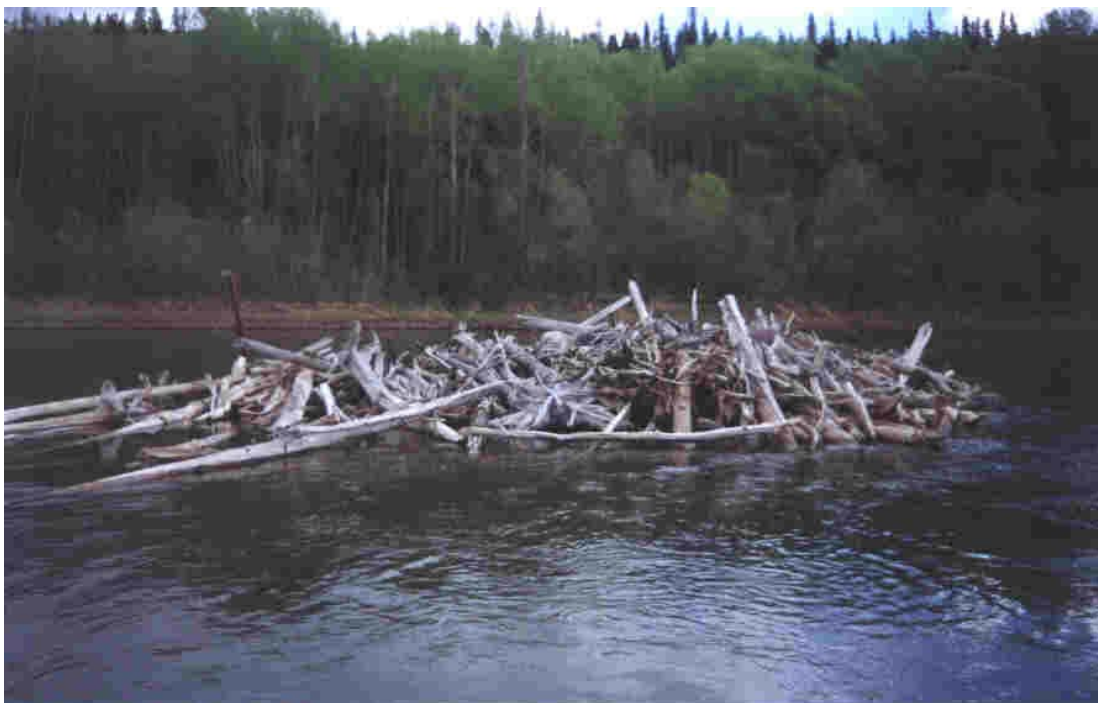
Photograph 12: Large accumulation (149 m²) at pipe-pile debris catcher (MC35.4 PDC, May 1995).

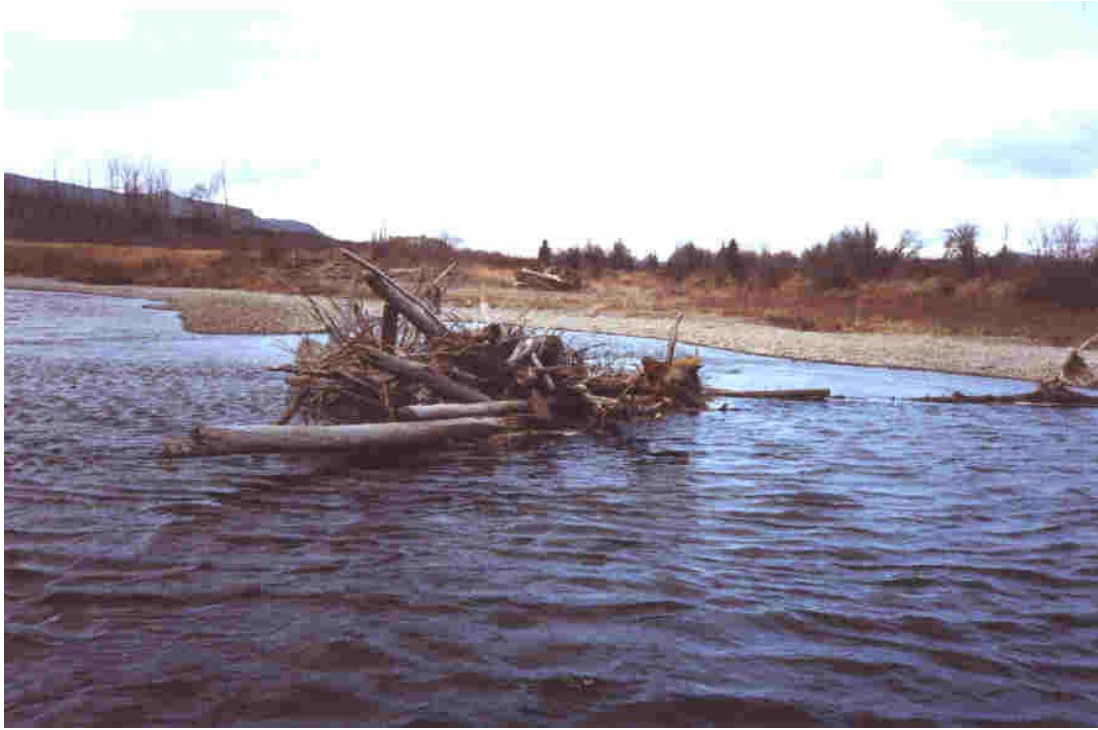
Photograph 13: Rail debris catcher (RM86.375RDC) showing significant debris capture (November 1993).

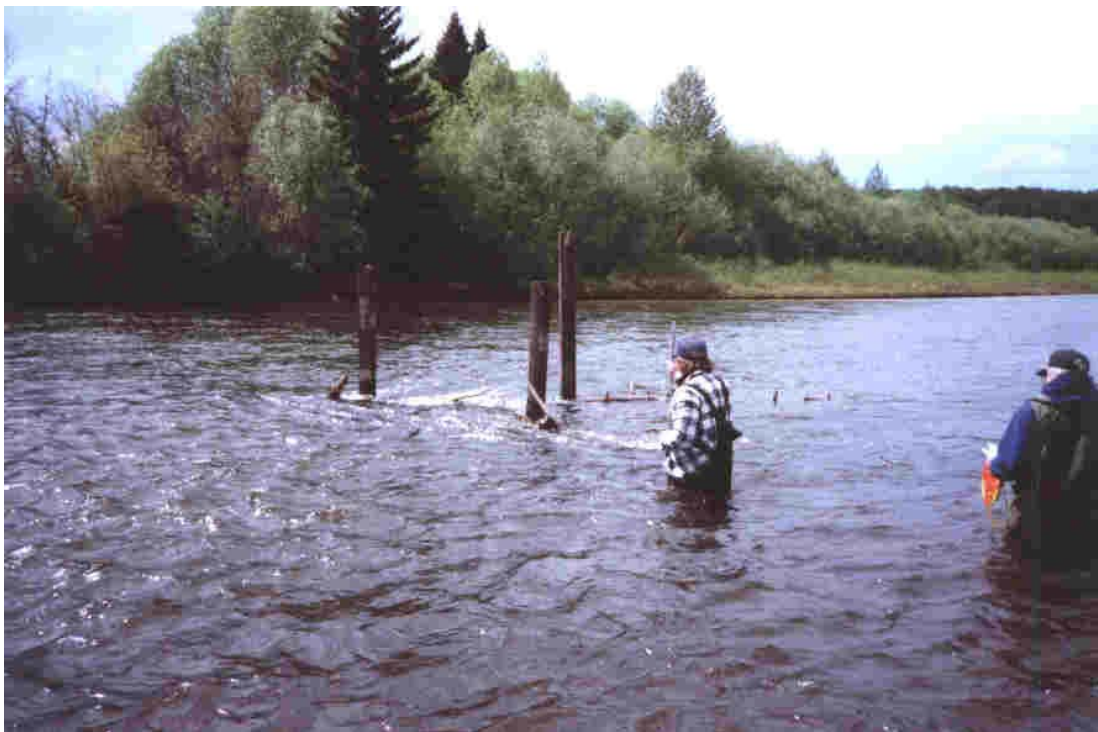
In 1995, two rail debris catchers were subsequently removed from ?? biological and physical assessments due to loss of debris after the summer cooling flows in 1994. Complex LM22.7RDC was changed to a control site and complex MC85.6RDC was changed to a natural site. The remaining rail debris catchers were generally stable with cover areas ranging from 8 to 137 m². Gravel was the predominant substrate, with cobbles and fines also generally present. Erosion was observed at 11 of the complexes, and sediment accumulation at three complexes.

Photograph 14: Rail debris catcher (MC85.6RDC) removed from 1995 physical assessment due to loss of all debris during summer cooling flows (May 1994).

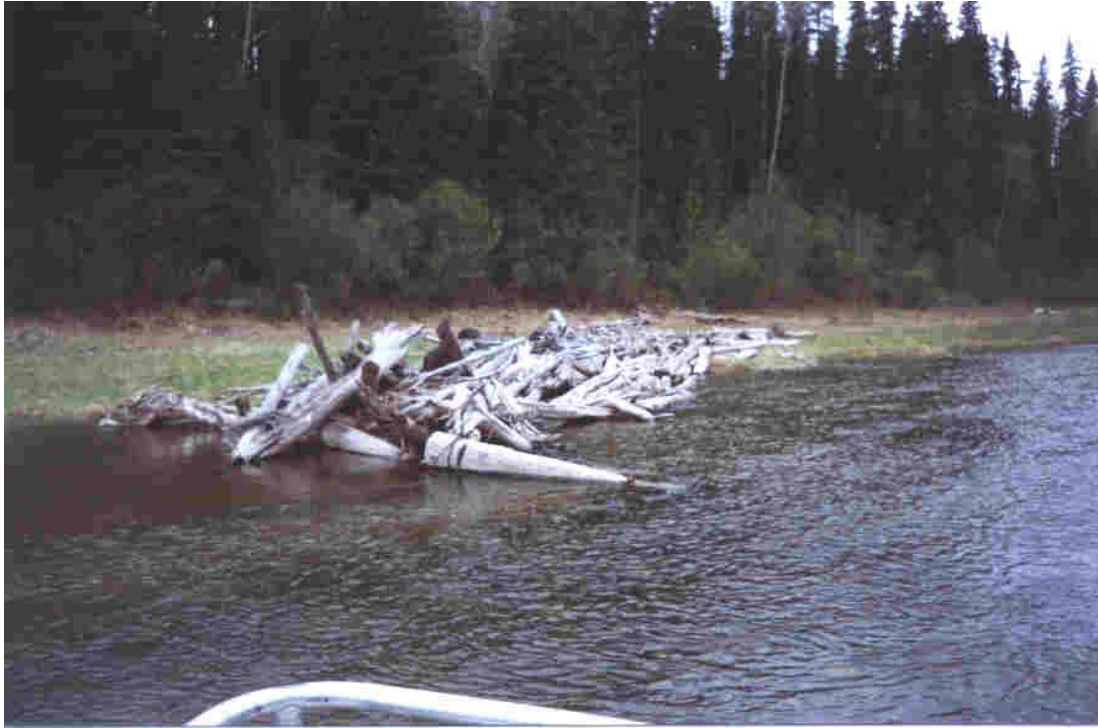
Cover area of the debris boom increased from 1994 to about 60 m². The structure remained stable despite damage to its shore deadman. Fines and gravels were the dominant substrates, with cobbles also present. Some sedimentation was observed downstream of the complex.

Photograph 15: Stable debris boom (RM17.9DB) providing 60 m² of cover area (May 1995).

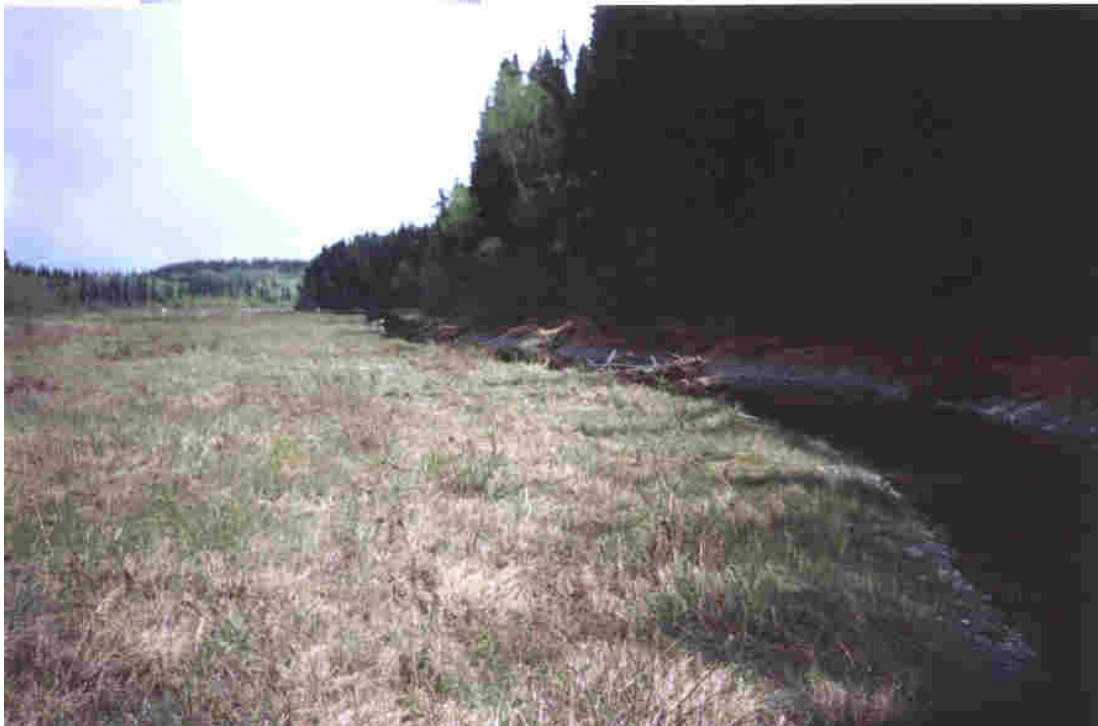
Photograph 16: Side channel (RM17.9SC) showing low water level, dewatered complexes and no velocity due to beaver dam blockage (May 1995).

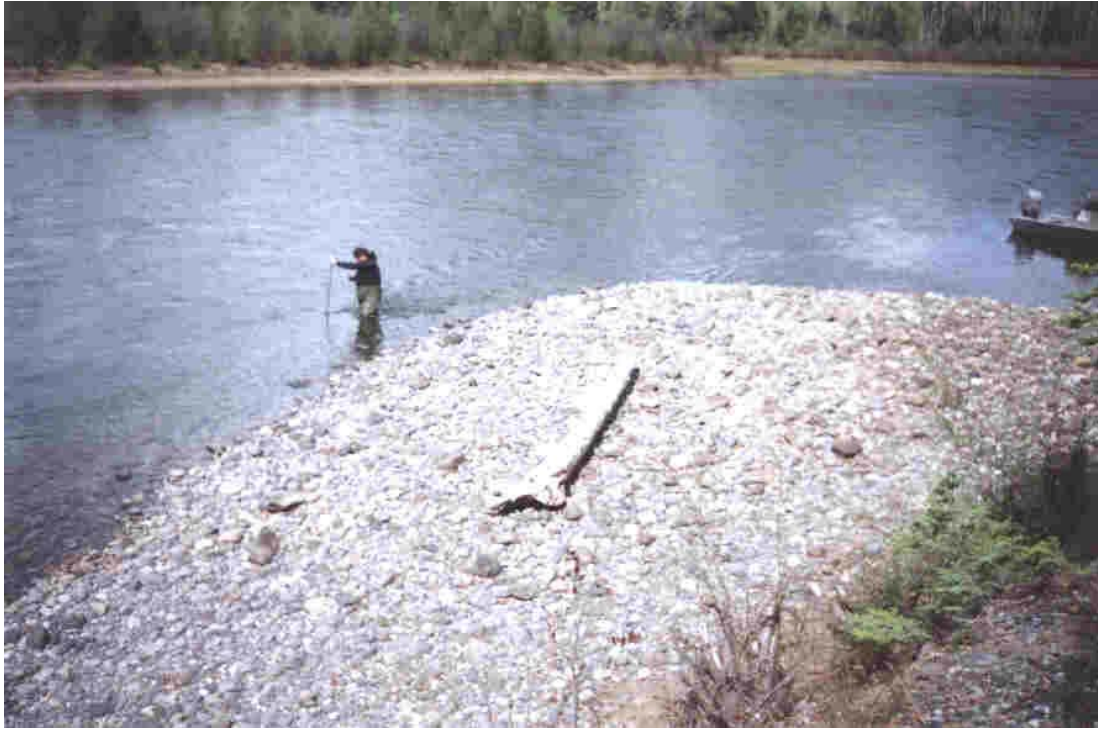
Photograph 17: Stable point bar RM17.0PB showing shear zone (May 1995).

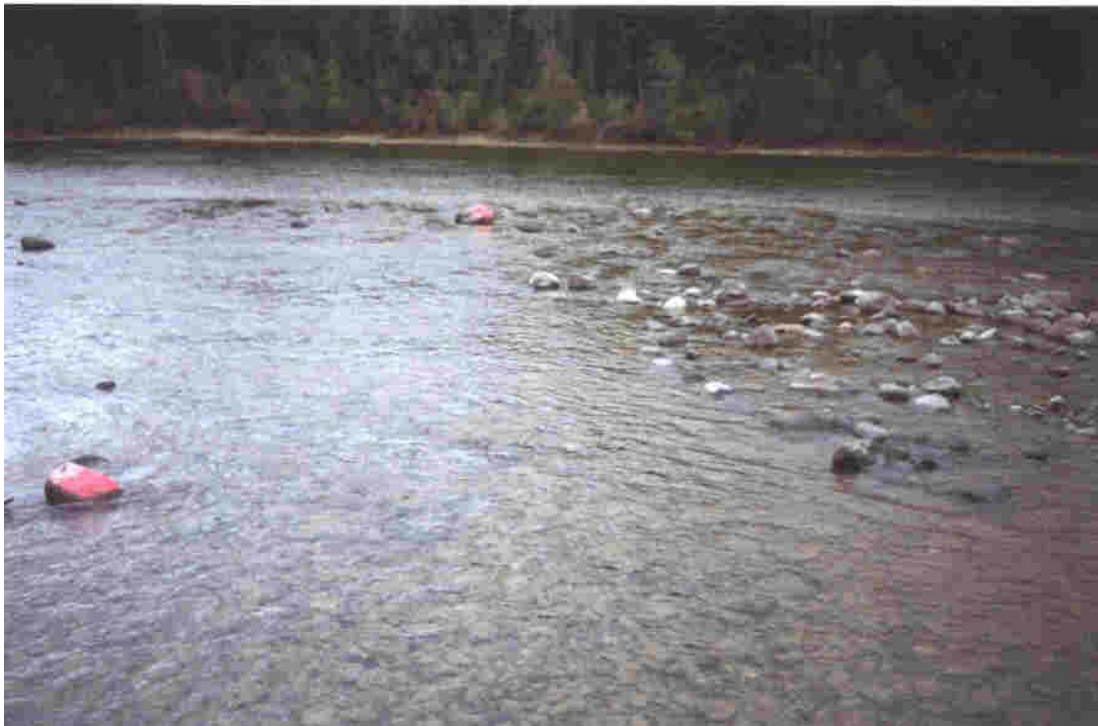
In 1994, due to significant erosion of the high velocity pocket pool, this complex was removed from further assessment. The remaining lower velocity complex continues to provide an adequate pool area with no noted erosion or sedimentation.

Photograph 18: Location of remaining pocket pool (MC15.7PP, May 1995). MC15.8PP removed from further physical assessment due to significant erosion..
