Routine Effectiveness Evaluations of Instream Restoration Treatments

Stony Creek and Corkscrew Creek

EDI Project No.: 05-BC-0170

March 2006

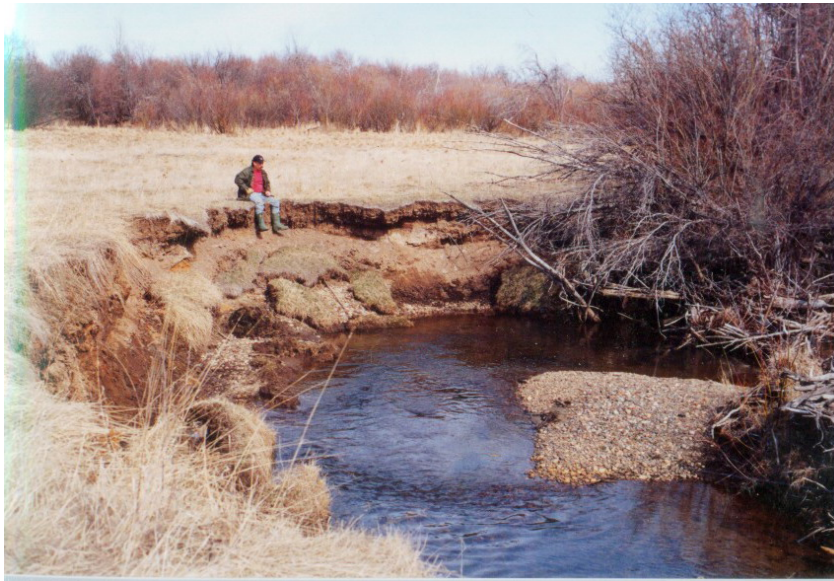
Corkscrew Creek, Reach 4 (Site 98-02) prior to revetment project. Photo taken downstream.

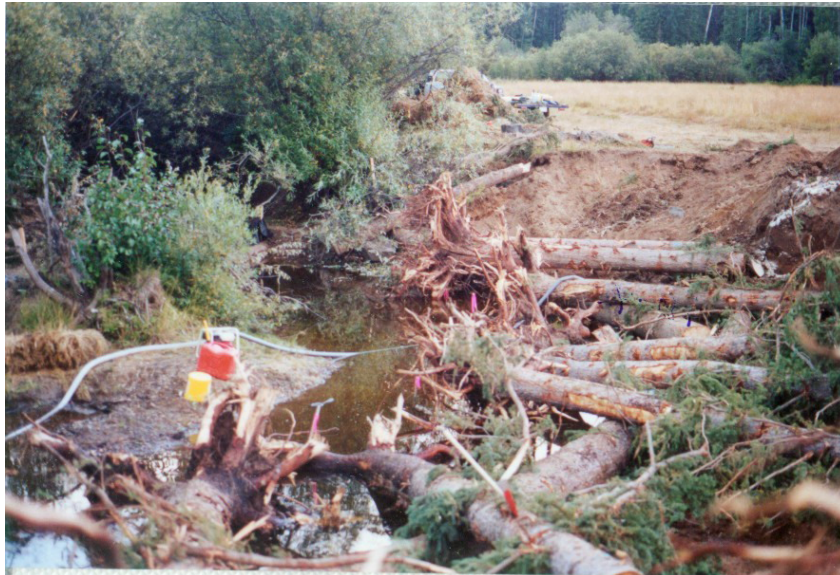
Corkscrew Creek, Reach 4 (Site 98-02) during revetment project. Photo taken upstream.

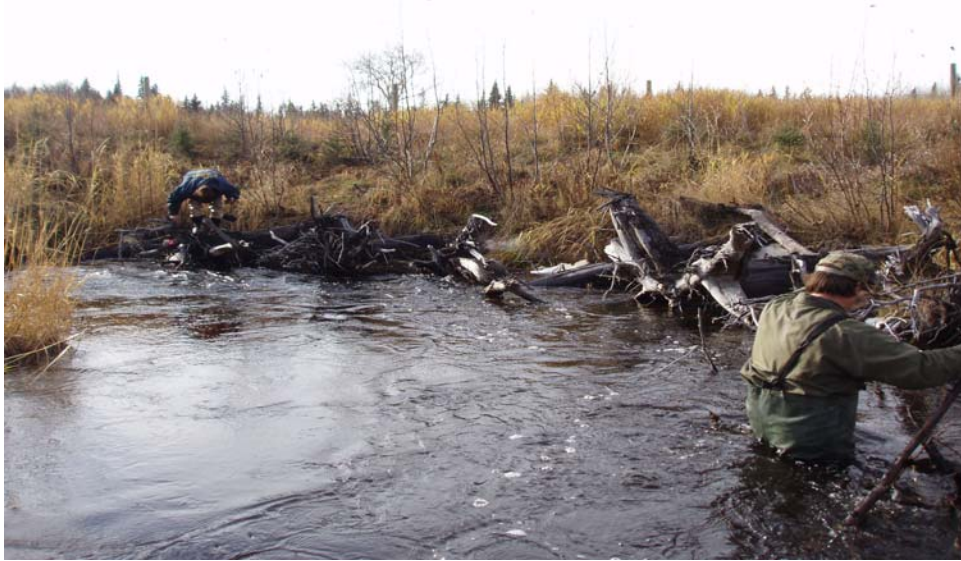
Corkscrew Creek, Reach 4 (Site 98-02) following revetment project in 2005. Photo taken upstream.

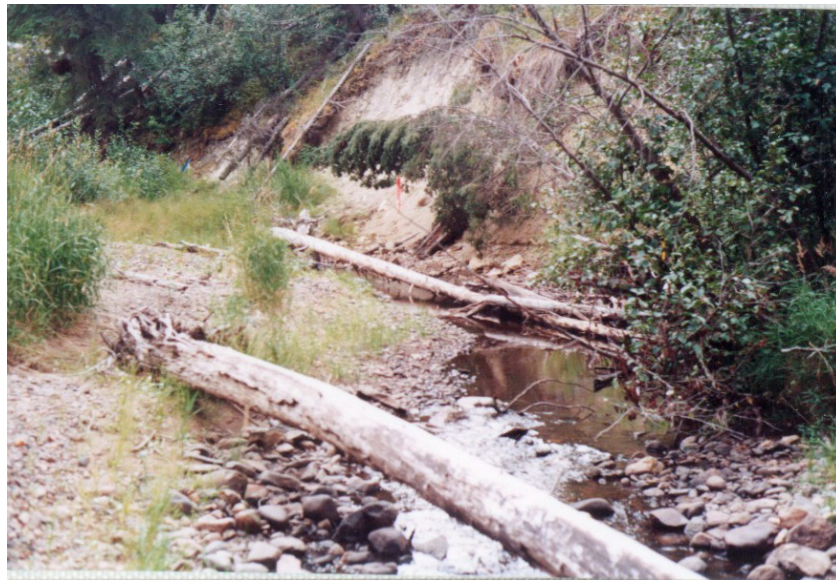
Corkscrew Creek, Reach 5 (Site 98-02) prior to construction of stabilizing structure.

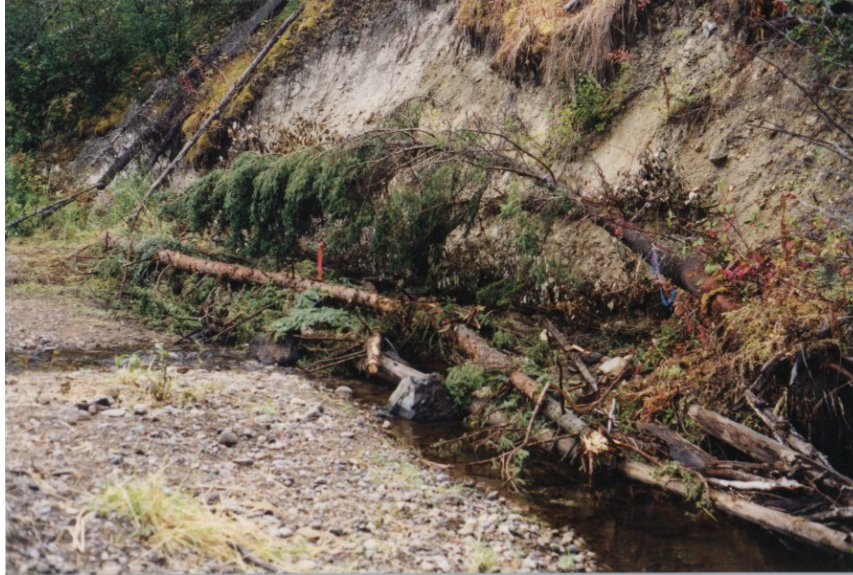
Corkscrew Creek, Reach 5 (Site 98-02) at time of construction of stabilizing structure.

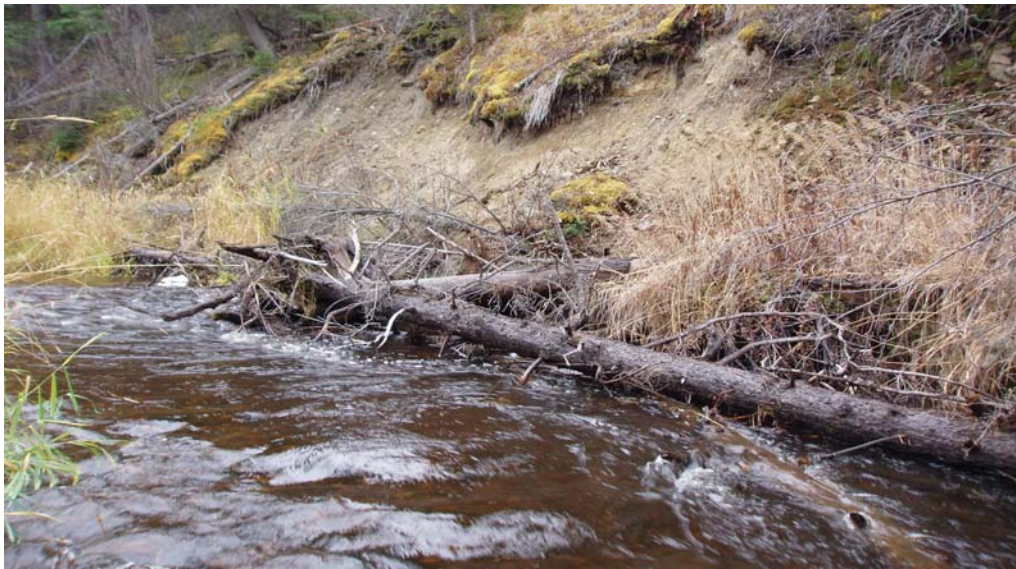
Corkscrew Creek, Reach 5 (Site 98-02) as of 2005. Note established grasses as indicator of stabilization.

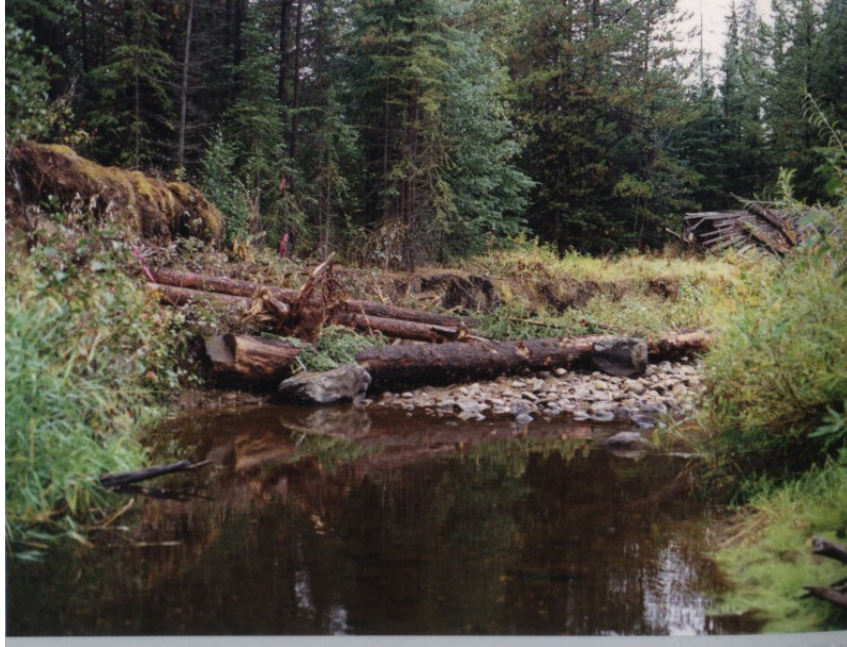
Corkscrew Creek, Reach 5 (site 98-05) at time of construction.

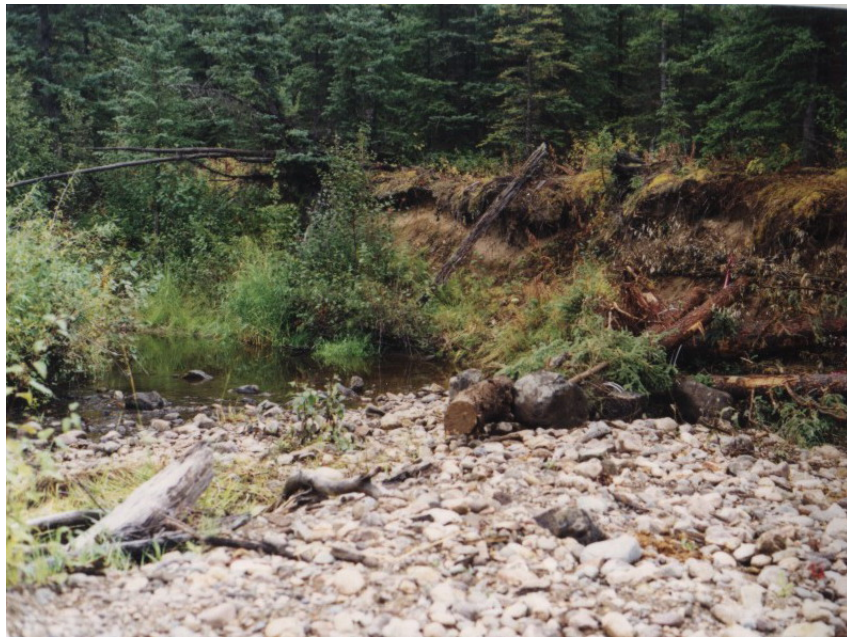
Corkscrew Creek, Reach 5 (site 98-05) at time of construction. Note lack of establish vegetation on the bar.

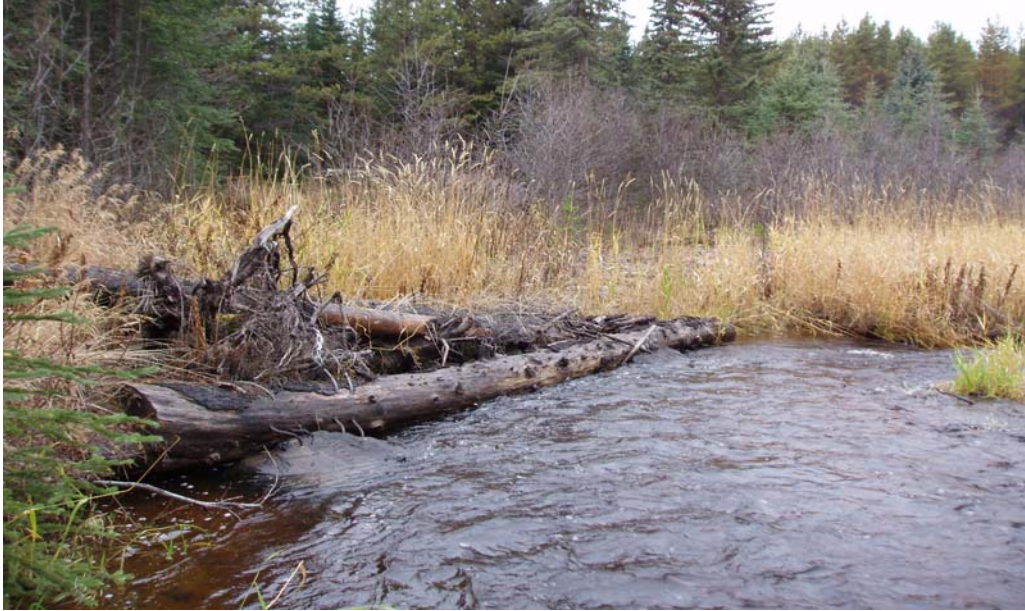
The overall structural condition and stability was rated effective for the channel stabilizing structures (Mean maintenance $3.8 \pm .52$). Restoration structures installed in Reach 5 were functioning well and meeting their overall objectives. A lateral deflector (site 98-05) was found to be functioning above expectations; the bar adjacent to the deflector was able to establish vegetation as a result of the structure.

Corkscrew Creek, Reach 5 (site 98-05). Photo taken in 2005. Note established vegetation on the bar and along left bank as an indicator of increased site stability.

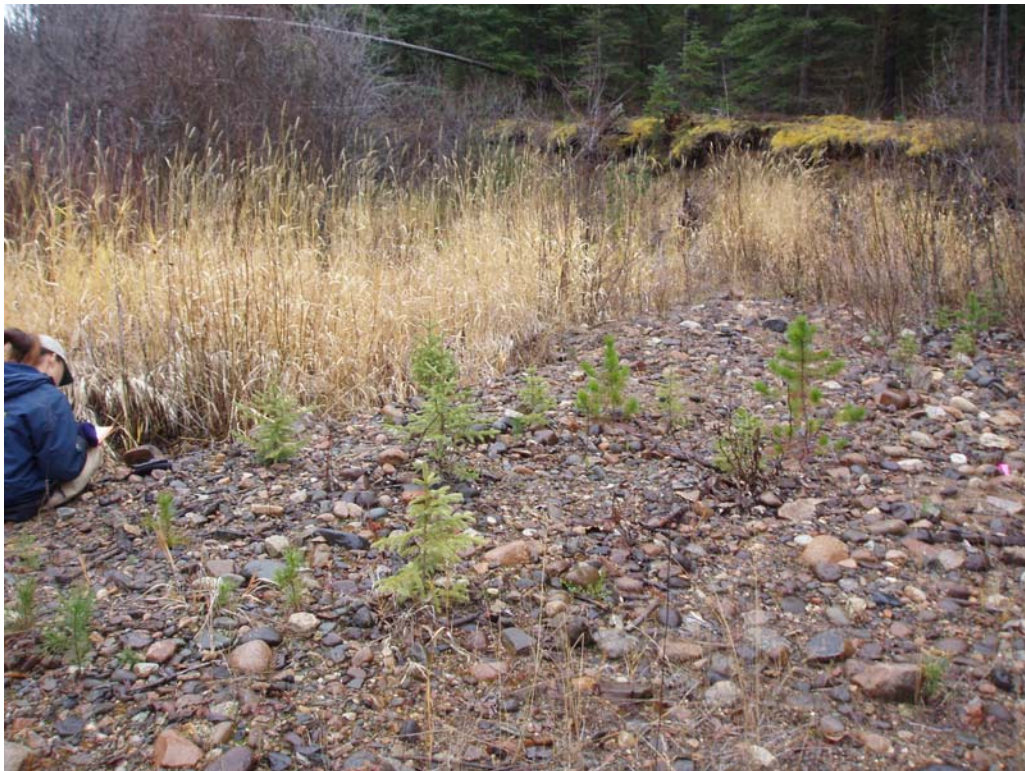
Corkscrew Creek, Reach 5 (site 98-05). Photo taken in 2005. Note established vegetation on the bar as an indicator of increased site stability.

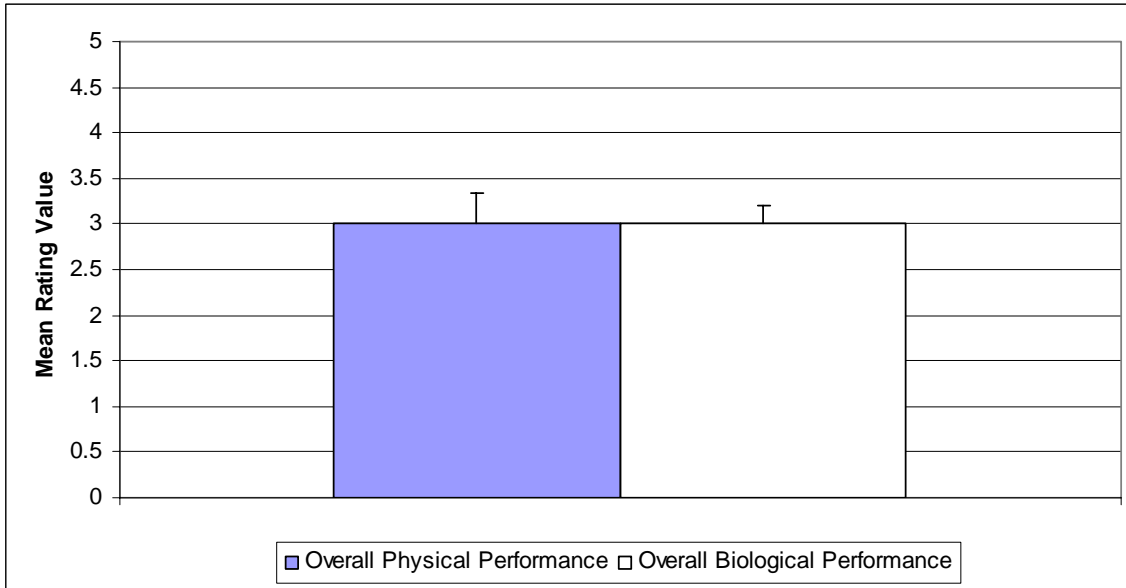
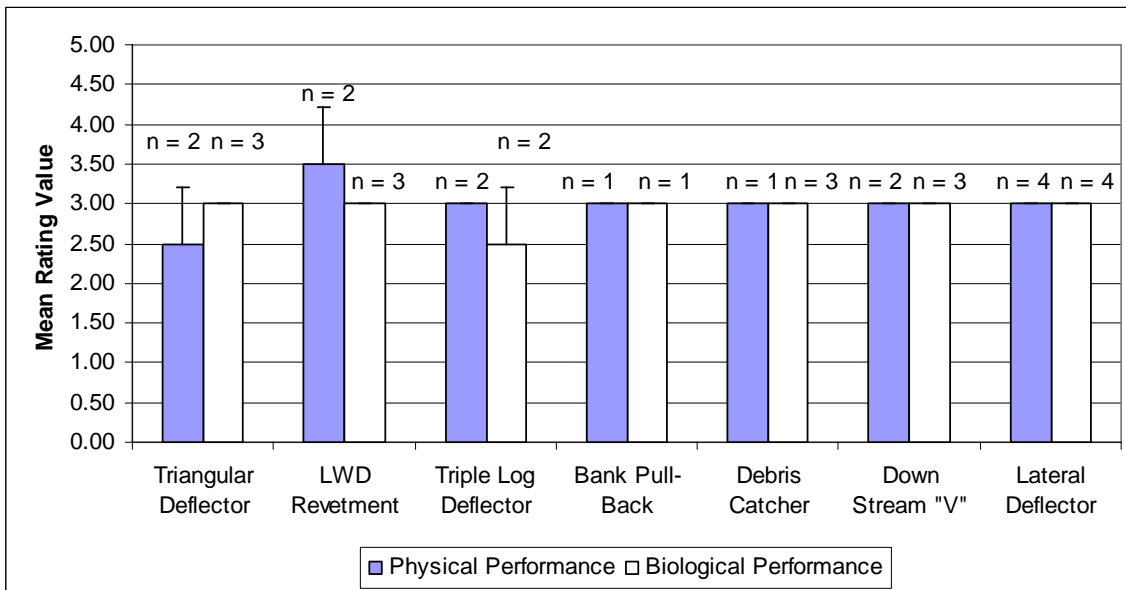
The overall structural condition and stability was rated effective for the channel stabilizing structures (Mean maintenance 3.3 ± 1.12). Most structures installed in Reach 4 were functioning well and meeting their overall objectives; however a triangular deflector (site 99-06) showed signs of decay necessitating replacement of the structural logs.

Figure 8. Summary of performance ratings across all structure types on Corkscrew Creek Reach 4 (\pm one standard deviation).

Figure 9. Summary of performance ratings for individual structures on Corkscrew Creek Reach 4 (\pm one standard deviation).
