EDI ENVIRONMENTAL DYNAMICS INC.
Natural Resource Consultants

**Nechako Coldwater Release Facility
Year 1 Pre-Engineering and
Environmental Studies – Nechako
Canyon and Cheslatta Fan**

EDI Project No.: 905-01

April 2003

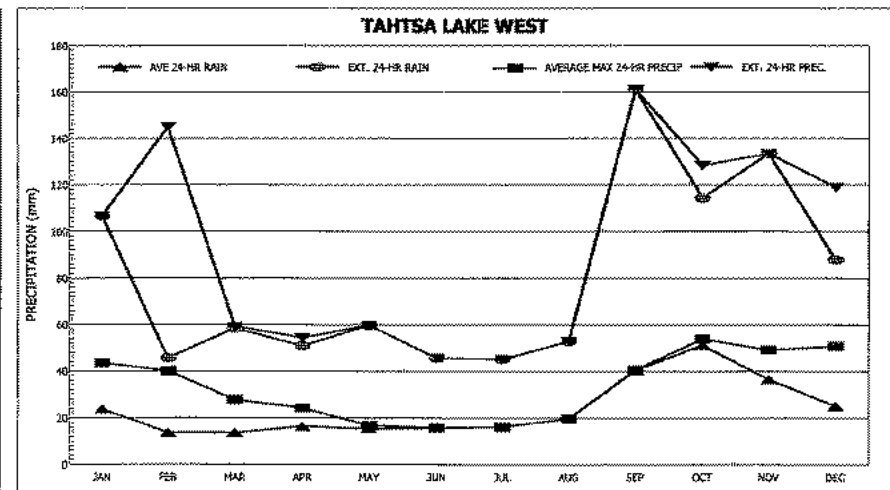
Figure 2.1.3-4 Seasonal variation in extreme 1-day rainfall and total precipitation (from 1961 to 1990 normals).

The seasonal variation in extreme 1-day rainfall and total precipitation is shown on Figure 2.1.3-4. This analysis indicates that 1-day rainfall intensities on the Nechako Plateau are of modest size. The maximum observed values of 50 to 63 mm are below Caine's (1980) criteria which indicates values of 100 mm/day are generally required to cause shallow landslides or debris flows in susceptible material.

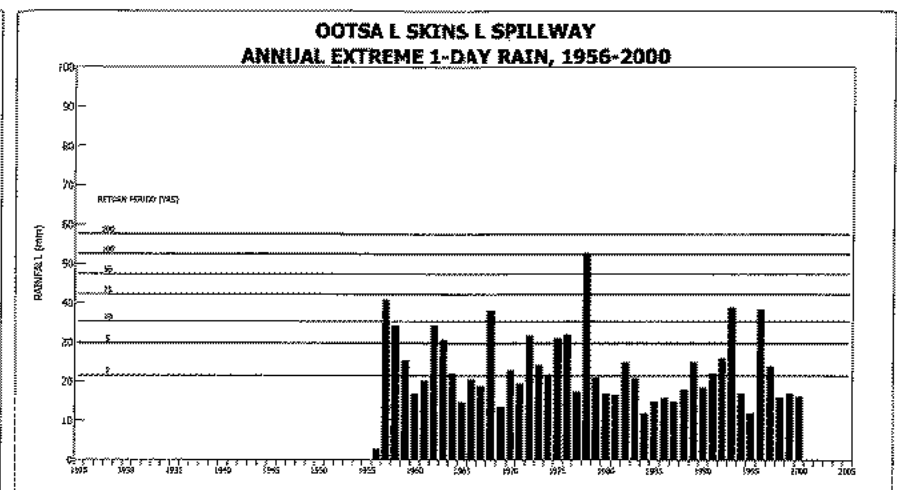
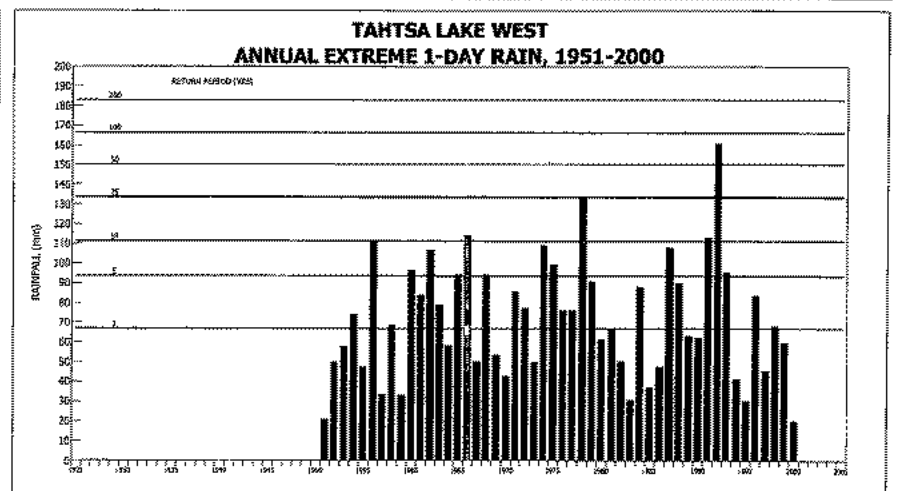
Figure 2.1.3-5 Historical variation in annual extreme 1-day rainfall.

The historical variation in annual extreme 1-day rainfall is shown on Figure 2.1.3-5. This analysis indicates that there is substantial regional variation in the 1-day rainfall events. As a consequence, heavy rainfall has generally not occurred simultaneously at the three Nechako Plateau sites. This suggests that maximum rainfall intensities are associated with local convective activity rather than larger frontal systems. Data from the “Ootsa Lake Skins Lake Spillway” indicates that the maximum 1-day rainfall occurred in 1978 and had an average return period of approximately 100 years (see Table 2.1.3-2). A larger event (having a return period of 200 years) occurred at Wistaria in 1993.

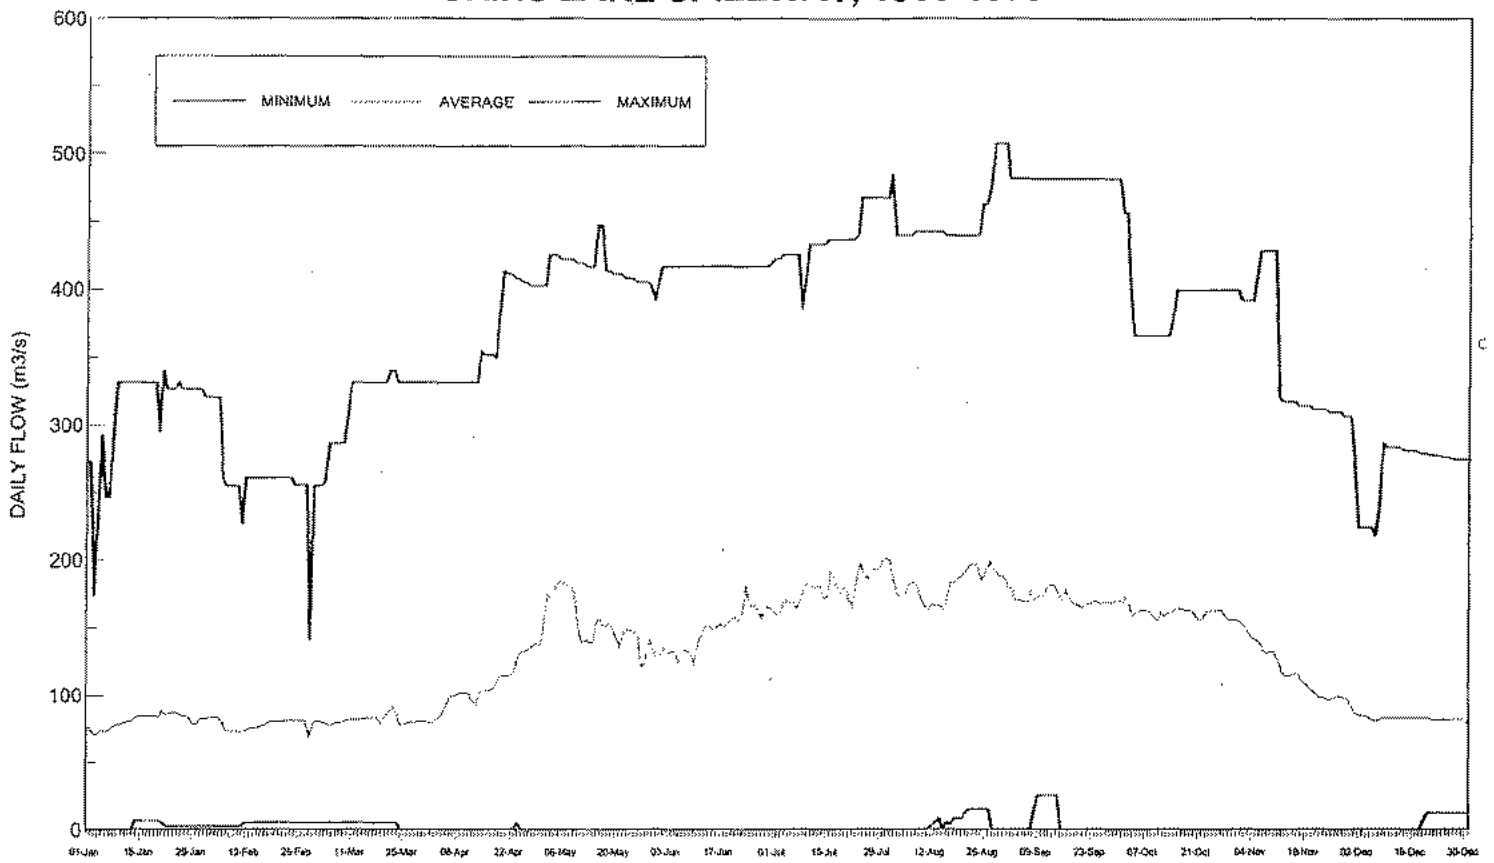
The post-regulation hydrographs from the Cheslatta River and Nechako River stations predominantly reflect the operating regime of the Skins Lake Spillway. Figures 2.1.4-3 to 2.1.4-7 show the maximum, average and minimum daily flows observed over the period of record. These data illustrate the altered characteristic of the annual hydrograph but are difficult to interpret as the spillway operating regime has varied over the life of the development. The daily flows at the “Skins Lake Spillway,” “Nechako River below Cheslatta Falls,” and “Nechako River at Vanderhoof,” along with daily water levels for “Cheslatta Lake at West End,” have been compiled¹. The “Skins Lake Spillway” data illustrate the change in timing and discharge that occurred following the adoption of the “short-term” cooling regime in 1980². Average monthly discharges generally decreased post-1980, although flows are regularly released from the reservoir starting in April and larger releases (of up to 450 m³/s) occur annually in mid-July to mid-August to provide cooling flows to the lower river. 1997 is anomalous as more substantive releases were undertaken throughout the summer to reduce water levels in the reservoir during this unusually wet year.

Figure 2.1.4-3 Seasonal variation in streamflow on Skins Lake Spillway, Nechako Reservoir, 1955 to 1979 and 1980 to 2001.

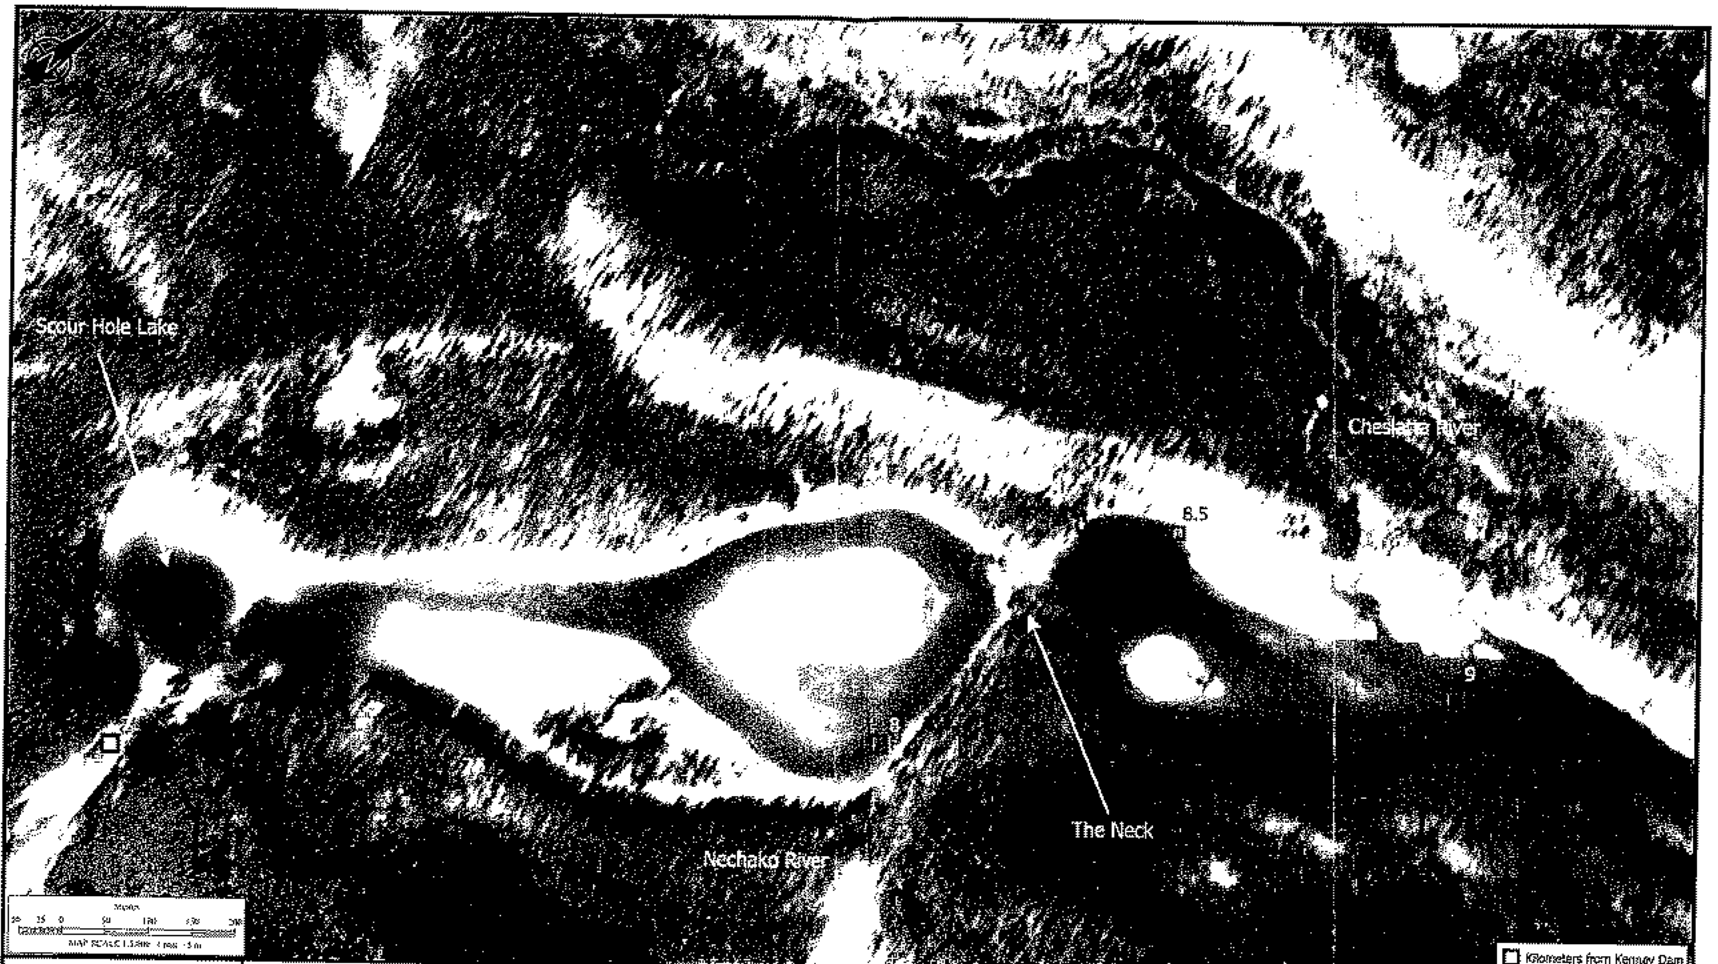
conditions in this area are illustrated on Figure 2.1.6-2 on the basis of 1949 air photos. The pre-regulation sediment deposits upstream of the Km 8.25 constriction are easily recognizable; as is a sizeable scour hole and additional sediment deposits in the downstream channel.

A11293 #34		September 20, 1949 Air Photo		APPROXIMATE SCALE: 1:5,000		M. MILES AND ASSOCIATES LTD. 645 ISLAND ROAD, VICTORIA, BC, V8S 2T7 Phone: 250-695-0603 Fax: 250-385-7367 email: mmmae@coastnet.com		PROJECT: NECHAKO RIVER COLD WATER RELEASE FACILITY	
				DATE: November 1, 2002				TITLE: NECHAKO RIVER AIR PHOTO MOSAIC SHOWING CONDITIONS IN 1949	
REFERENCED DRAWING NO.		REFERENCED DRAWING DESCRIPTION				DRAWN: S. Gibbins			
A	Nov. 1, 2002	Issued For Discussion	SG	MM	DESIGNED: S. Gibbins				
B	Jan. 23, 2002	Issued For Report			CHECKED: M. Miles				
					APPROVED: M. Miles		CLIENT: NECHAKO ENHANCEMENT SOCIETY		
						FIGURE 2.1.6-2		PROJECT NO. 219	REV: A
								Km NO. 7 to 9

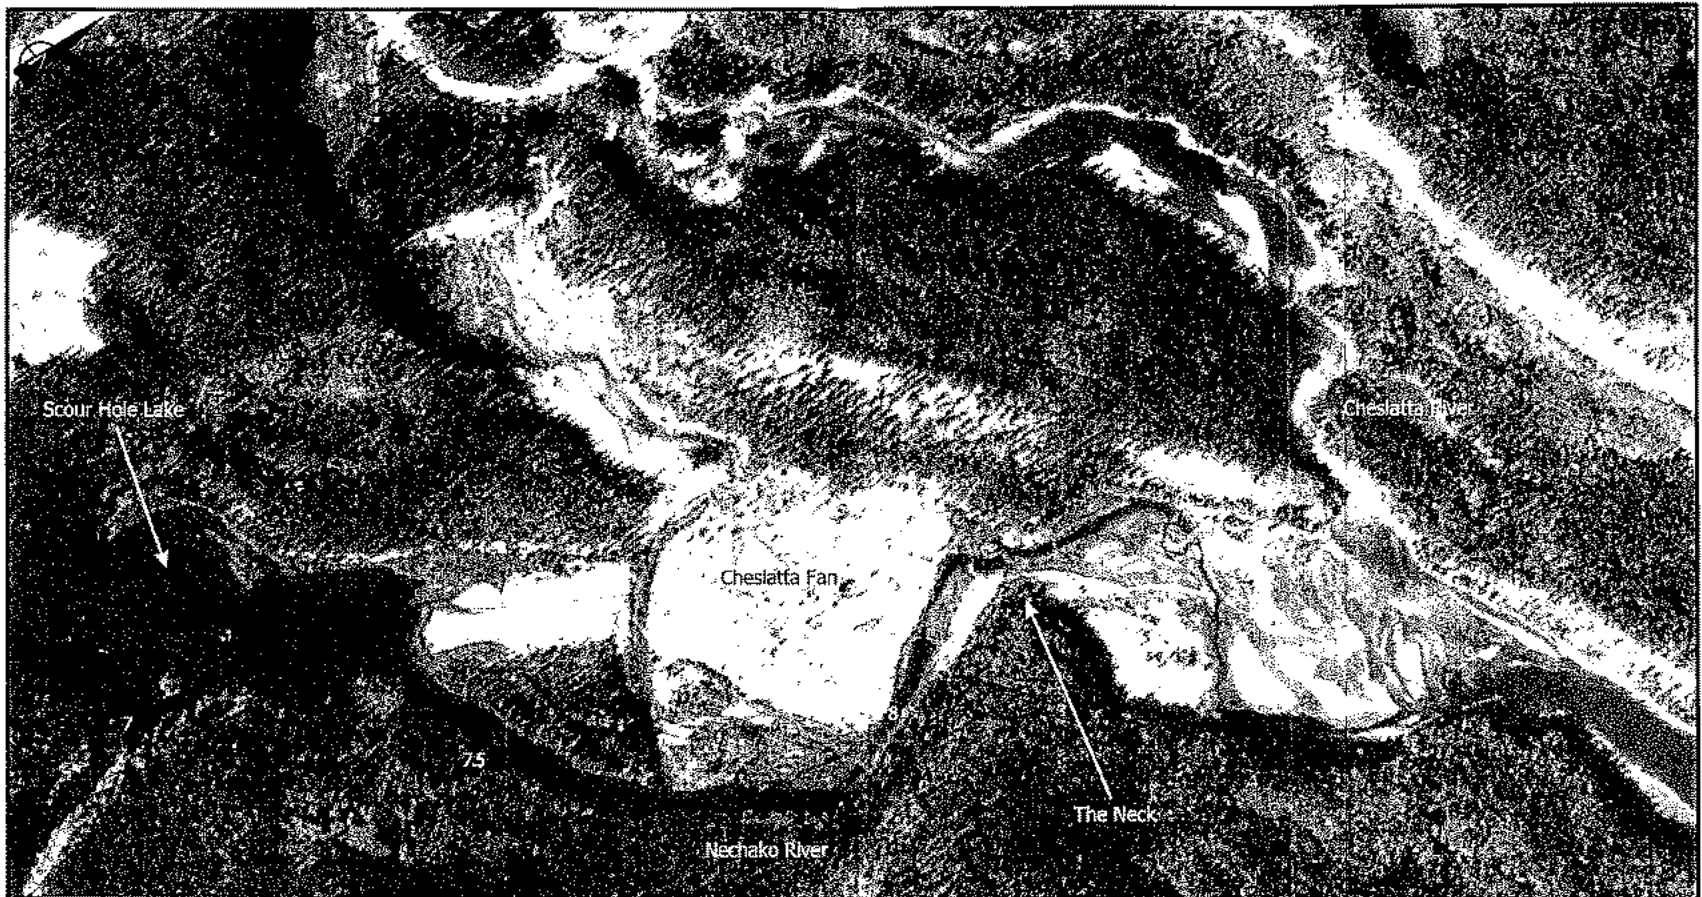
There has been relatively little change in channel conditions in Nechako Canyon in the post-regulation period (this will be discussed further in Section 3.3.2); however, as indicated by Figure 2.1.6-3, substantial changes have occurred at the Cheslatta confluence. Cheslatta River breached its right bank just downstream of the Holy Cross Forest Service Road bridge and cut a massive gully through a thick unconsolidated sequence of glaciofluvial gravels, lacustrine sediments and till thus by-passing Cheslatta Falls. The eroded materials were redeposited in the form of a large alluvial fan on the floor of the Nechako Valley, both upstream and downstream of the constriction at Km 8.25. A saddle dam was constructed at the entrance to the diversion channel in the mid 1970's (Dhaliwal pers. comm.) and the Cheslatta River was forced back over Cheslatta Falls. Rood and Neill (1987) estimate that approximately $0.9 \times 10^6 \text{ m}^3$ of sands and gravels were eroded by this channel relocation and that 0.4 to $0.5 \times 10^6 \text{ m}^3$ was deposited in Nechako River above Cheslatta Falls. The remainder of the material has been carried downstream. The historical air photos in Appendix 2 (Sheets 5 and 6) provide a good illustration of how this feature has changed in the period since 1950.

3CBCC00020 #59		September 22, 2000 Air Photo		APPROXIMATE SCALE: 1:5,000		M. MILES AND ASSOCIATES LTD. 645 ISLAND ROAD, VICTORIA, BC, V8S 2T7 Phone: 250-595-6553 Fax: 250-595-7367 email: mmaa@peasinet.com		PROJECT: NECHAKO RIVER COLD WATER RELEASE FACILITY	
REFERENCED DRAWING NO.		REFERENCED DRAWING DESCRIPTION		DATE: August 26, 2002		DRAWN: S. Gibbins		TITLE: NECHAKO RIVER AIR PHOTO MOSAIC SHOWING CONDITIONS IN 2000	
A	Aug. 26, 2002	Issued For Discussion	SG	MM	DESIGNED: S. Gibbins	CLIENT: NECHAKO ENHANCEMENT SOCIETY		PROJECT NO. 219	REV: A
B	Jan. 23, 2003	Issued For Report			CHECKED: M. Miles			FIGURE 2.1.6-3	
				APPROVED: M. Miles				Km NO. 7 to 9

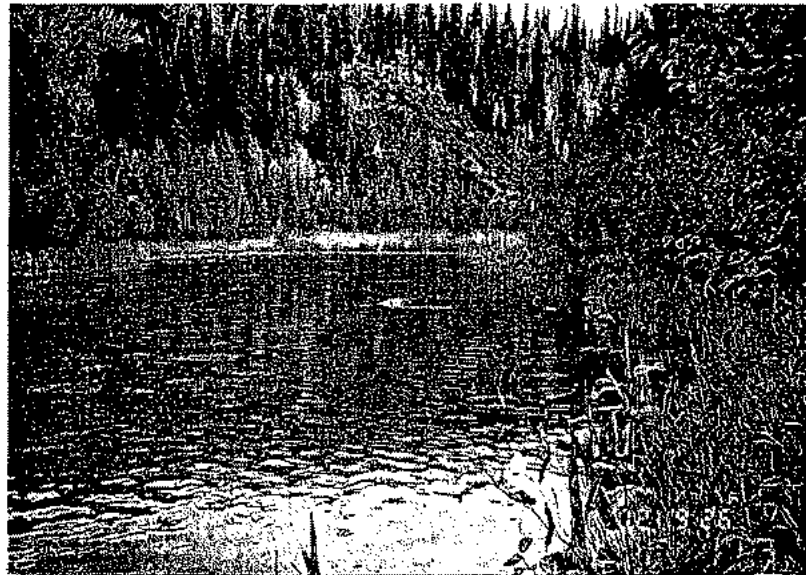
Plate 3.3.1-2

Two-aged forest stand structure in Nechako Canyon. Two-aged forest stand structure in Nechako Canyon, with small spruce (generally under 5 m height) on surfaces exposed as a result of canyon dewatering, with older and larger conifer and broadleaf deciduous forest stands occupying the slopes above pre-Kenney Dam flood levels. Location: floor of Nechako Canyon, viewed to northwest over north end of pond approximately 0.6 km downstream of Kenney Dam.

Spruce is the dominant small conifer on valley bottom sites of the canyon where there is mineral or organic soil accumulation, as shown at the far edge of the pond in Plate 3.3.1-2. Lodgepole pine is the dominant small conifer where there are gravel or boulder surfaces in the dewatered zone (Plate 3.3.1-3). Both Plates 3.3.1-2 and 3.3.1-3 demonstrate the small sizes of trees that would be subject to removal during flushing of the canyon. Some of the young spruce stands that have developed near some of the beaver dams or near other ponds on the valley floor have a relatively dense tree cover (Plate 3.3.1-2). In contrast, most of the pines that have established on boulder surfaces are not only small but also sparsely spaced (Plate 3.3.1-3).

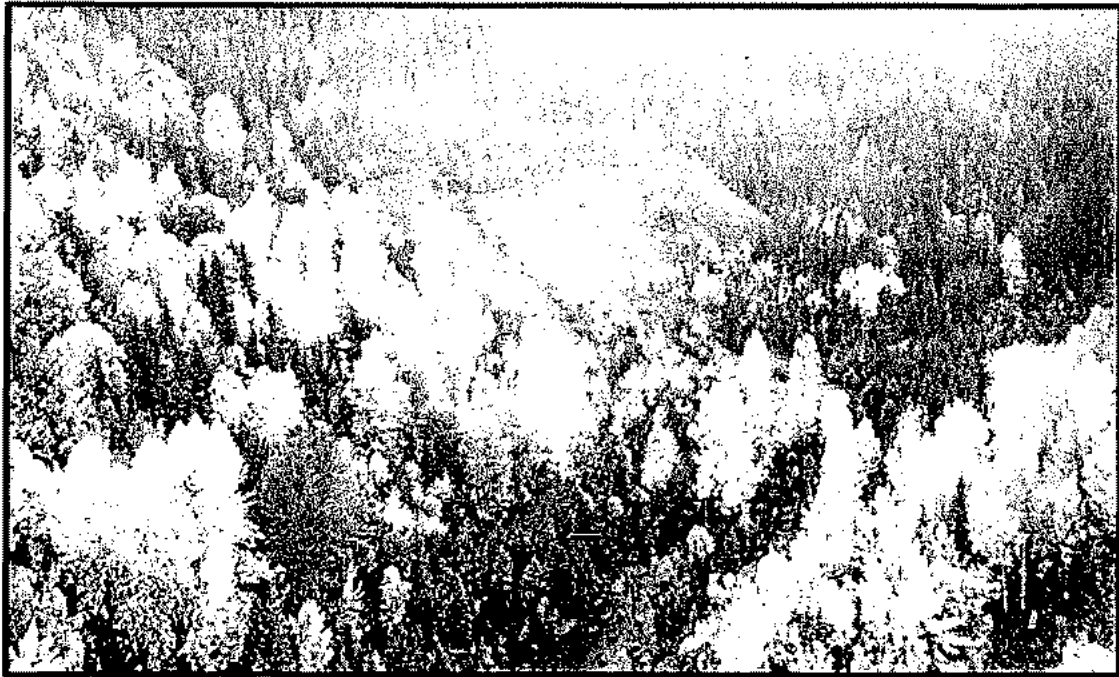
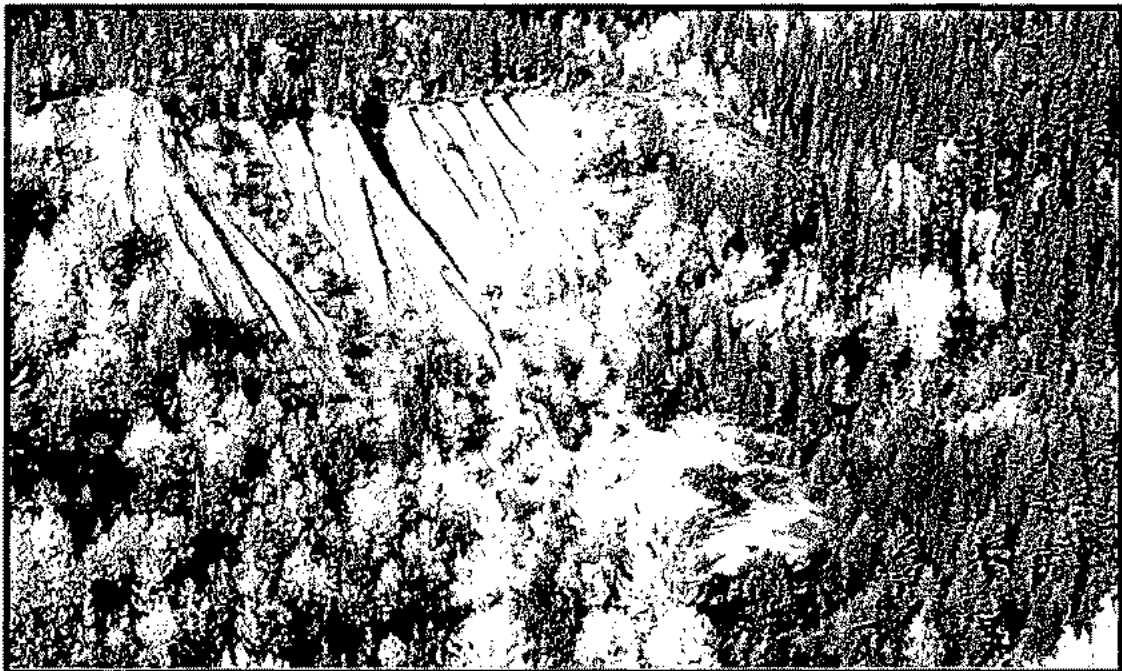
Plate 3.3.2-1 Looking downstream to the left bank spoil pile at Km 0.4. Slope erosion has resulted in sediment deposition in the adjacent section of channel

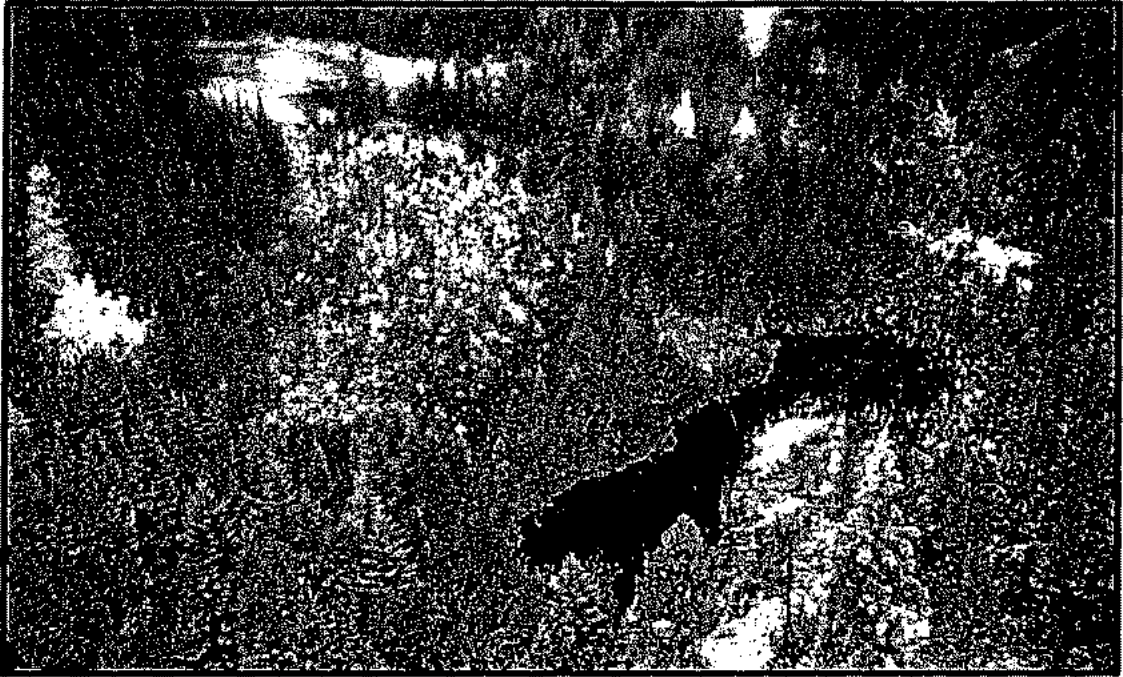
MM 02 - 89 - 15A

A) Looking upstream to the remnant point bar at Km 1.2

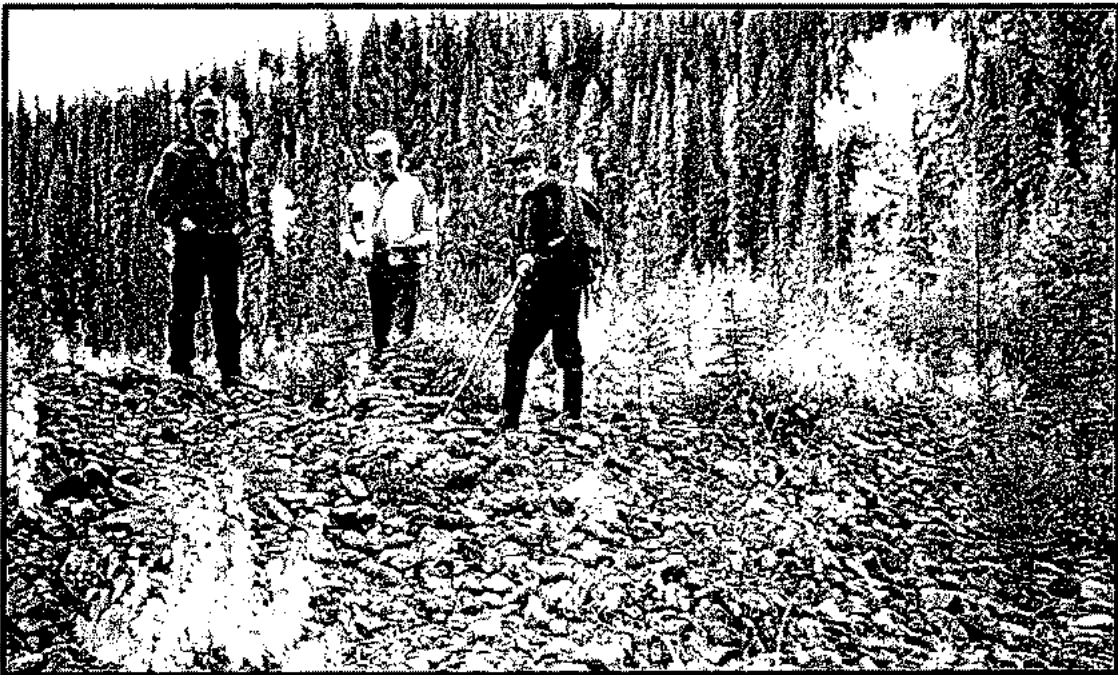
MM 02 - 82 - 24A

B) The surface of the bar consists principally of cobble (Km 1.2).

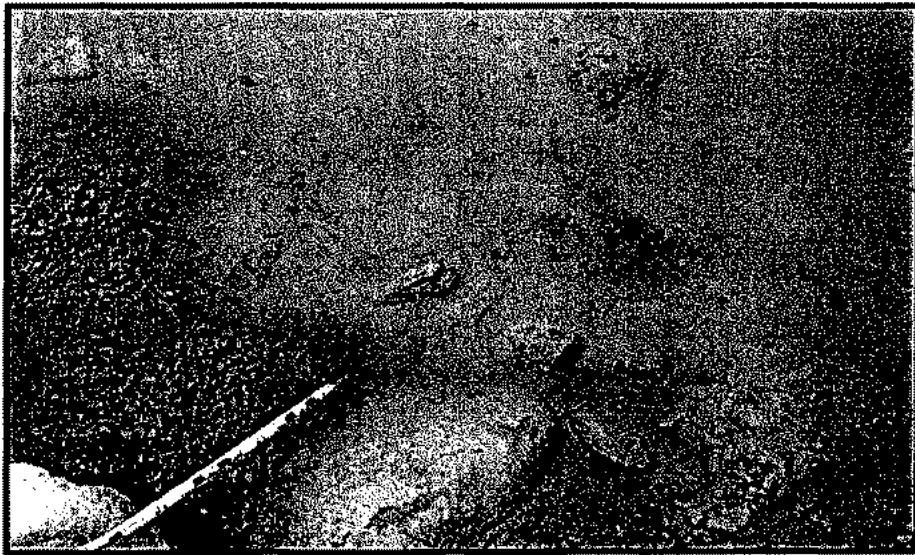
MM 02 - 85 - 27

Plate 3.3.2-4 Fine textured organic rich sediments have accumulated in the small ponds which have formed in the upper 4 kilometres of the Nechako Canyon

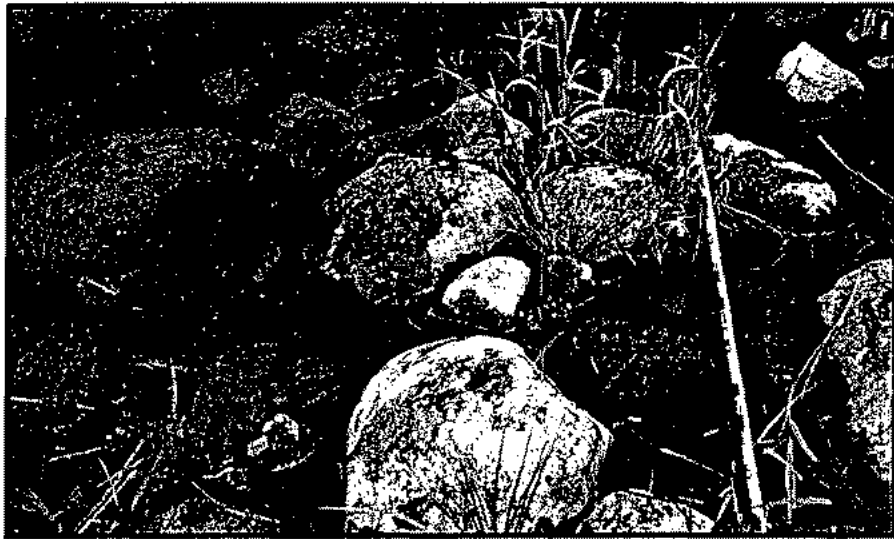
A) Looking downstream at Km 1.0

Plate 3.3.2-5 Relatively little sediment deposition has occurred along the edges of most ponds

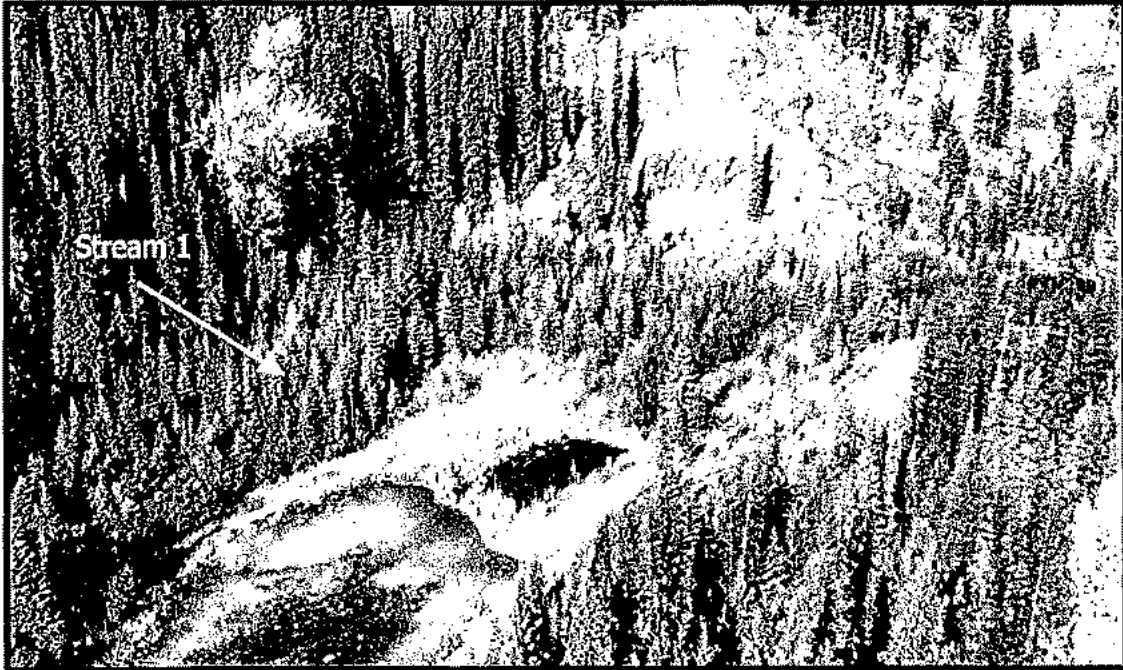
MM 02 - 90 - 4A

Plate 3.3.2-6 Looking downstream showing the vegetated left bank sediment deposits located in Nechako Canyon at the confluence with Stream 1

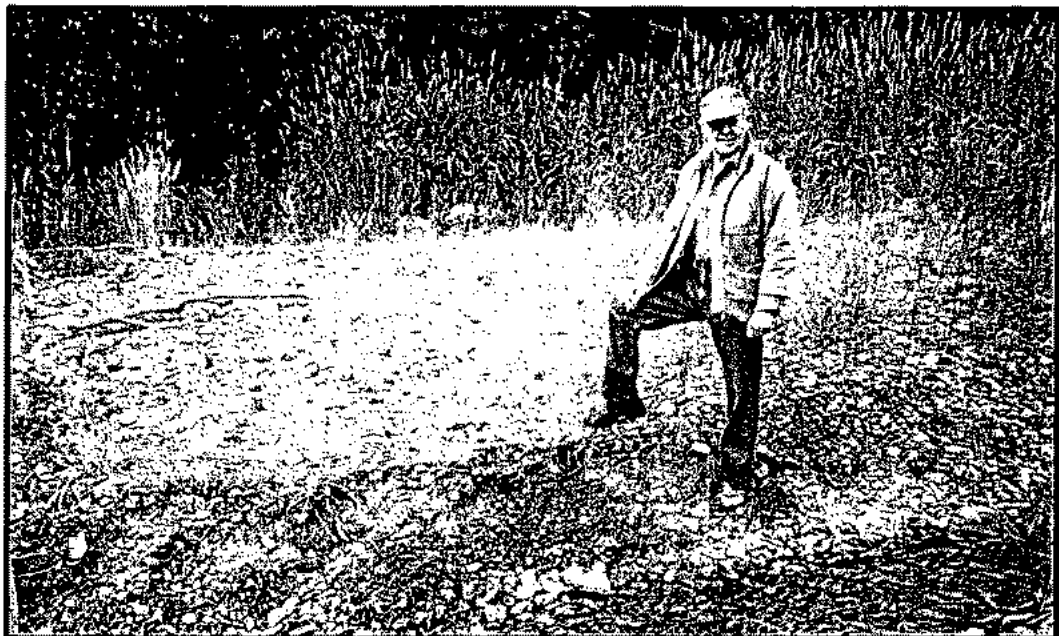
A) Looking downstream to the fan between the lakes at Km 2.4 and 2.7

Plate 3.3.2-7 Sand and gravel sized sediments have accumulated in the Nechako Canyon at the confluence with Stream 2

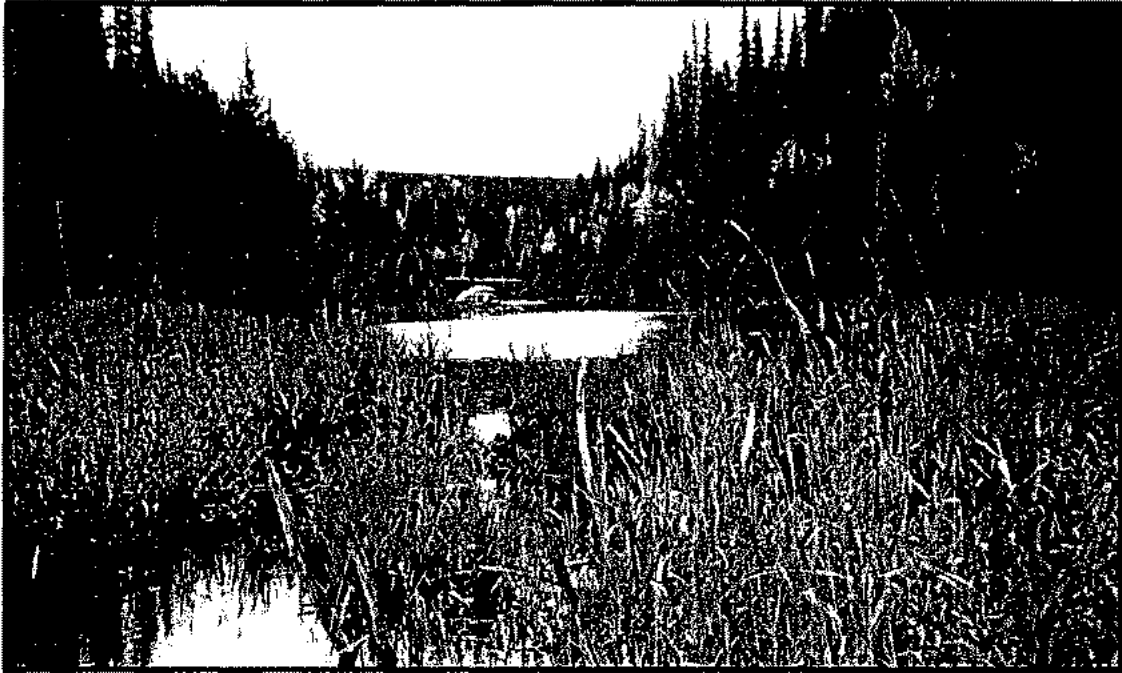
Looking upstream to the beaver dams located at Km 1.2

Plate 3.3.2-8 Quantities of sediment and organic debris have been locally stored in beaver dams located within the Nechako Canyon

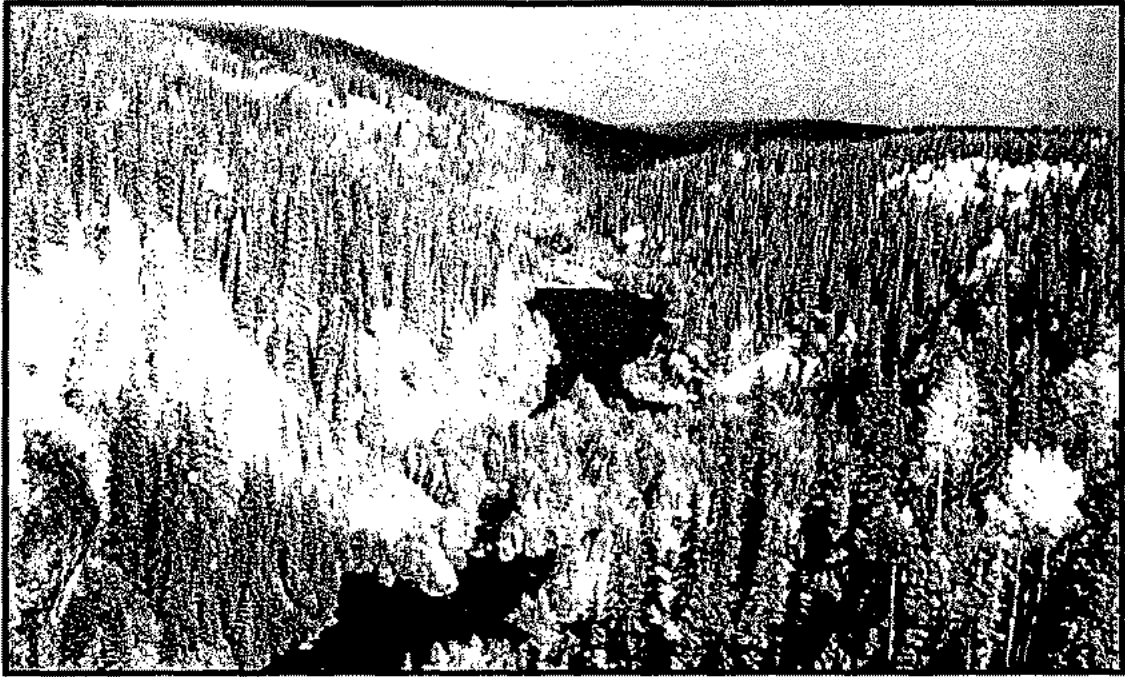
MM 02 - 86 - 15

Plate 3.3.2-9 Looking downstream towards the historic right bank landslide located between Km 2 and 2.8, showing the lack of recent sediment production

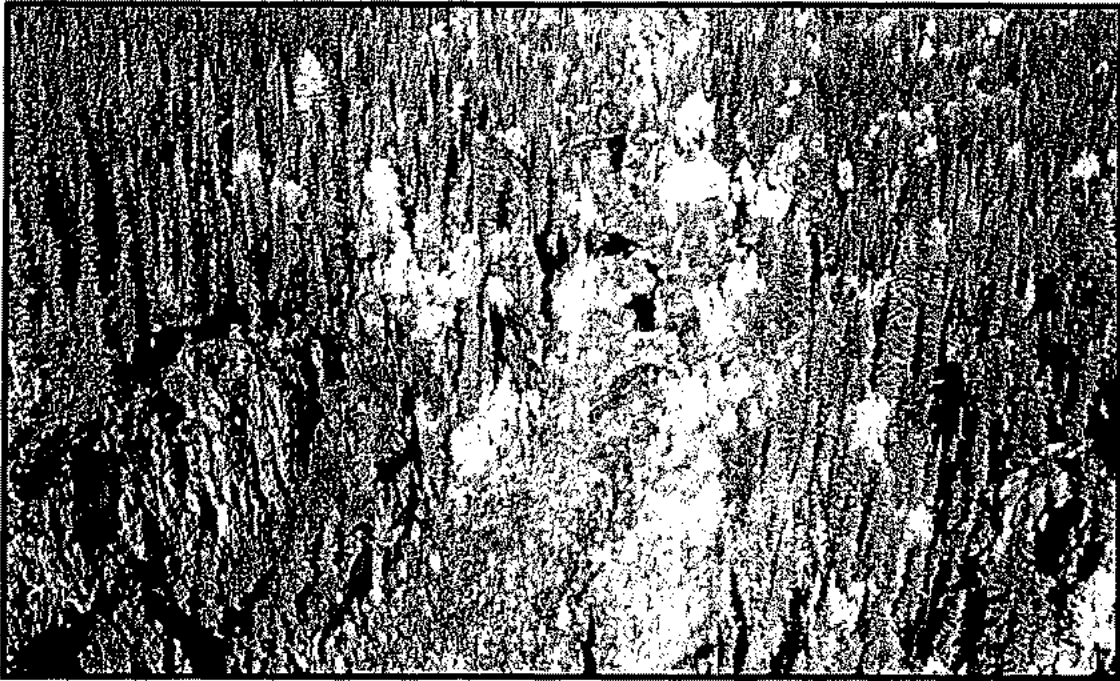
A) Looking downstream at Km 5.2

B) Looking upstream at Km 6.5

Plate 3.3.2-11 Representative photographs of the Nechako Canyon, showing the lack of sediment accumulations which occur downstream of Km 4
