Routine Effectiveness Evaluations of Instream Restoration Treatments

Stony Creek and Corkscrew Creek

EDI Project No.: 05-BC-0170

March 2006

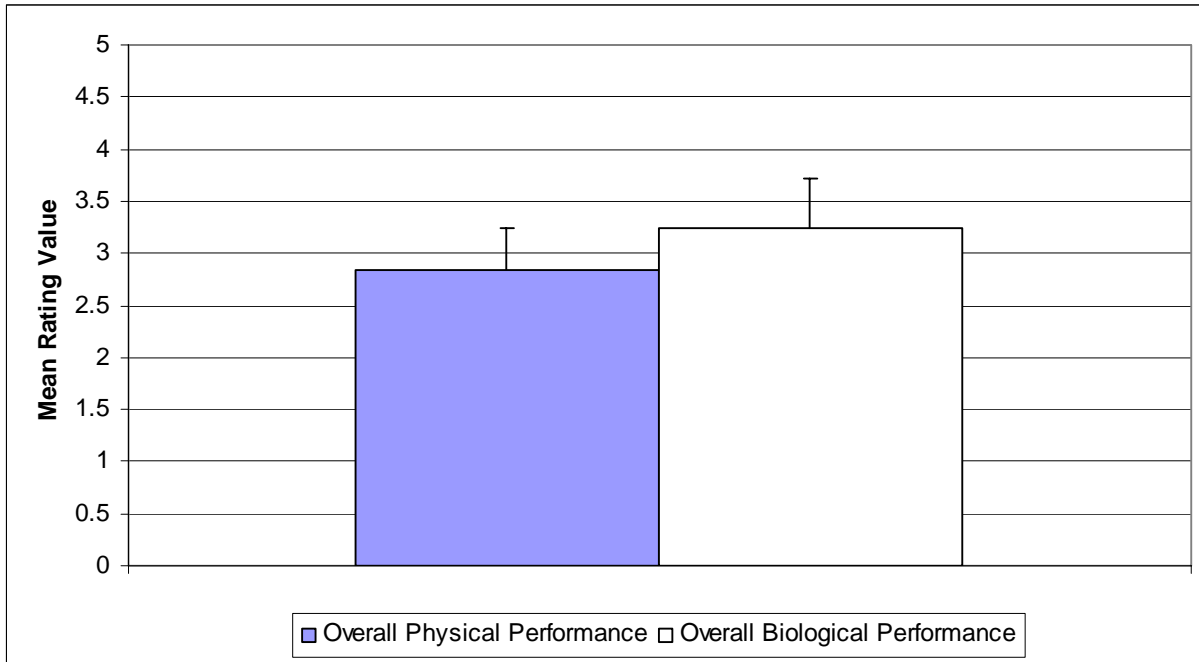
A total of 3 structures were evaluated for physical and biological performance (Table 4). The pooled mean for the associated physical performance objective for the structure types evaluated was 2.8 ± 0.4 , and the biological performance objective was 3.3 ± 0.5 (Figure 2). The individual structures in this reach were: single log deflector (n=1), lateral debris jam (n=1) and lateral deflector (n=1). The physical and biological performance for each structure is summarized in Figure 3. Tables and figures referenced within this section can be viewed in Appendix II – Tributary III, Reach 1. Photos of each structure are contained in Appendix XI.

Figure 2. Summary of performance ratings across all structure types on Tributary III Reach 1 (\pm one standard deviation).

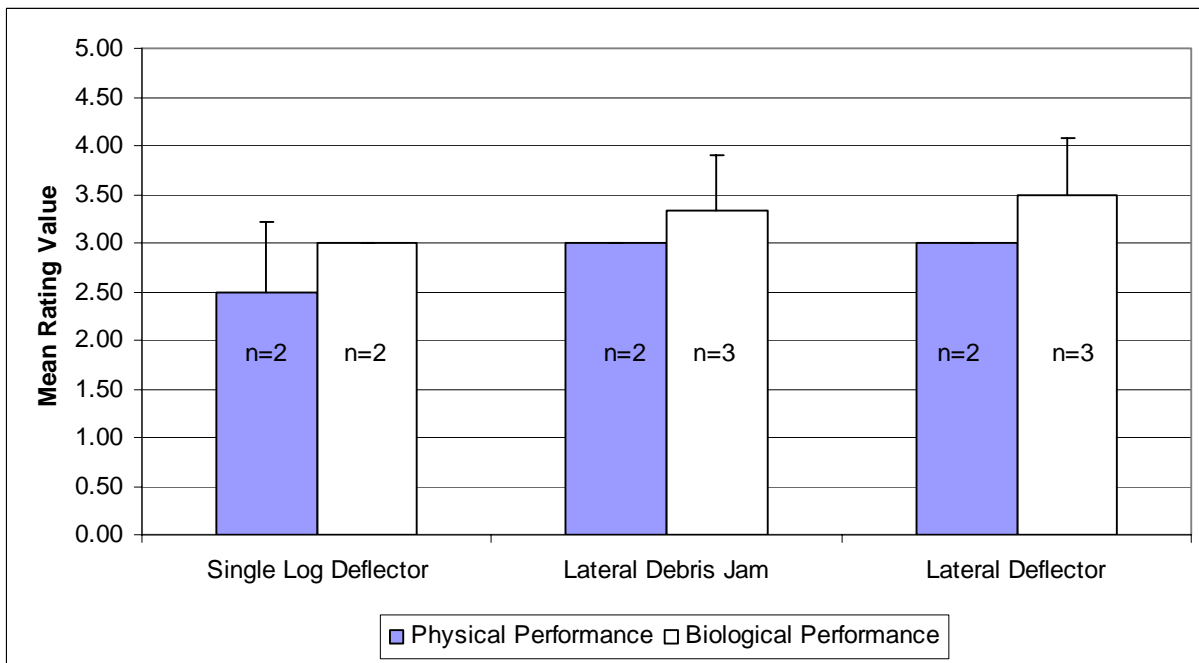
Figure 3. Summary of performance ratings for individual structures on Tributary III Reach 1 (\pm one standard deviation).

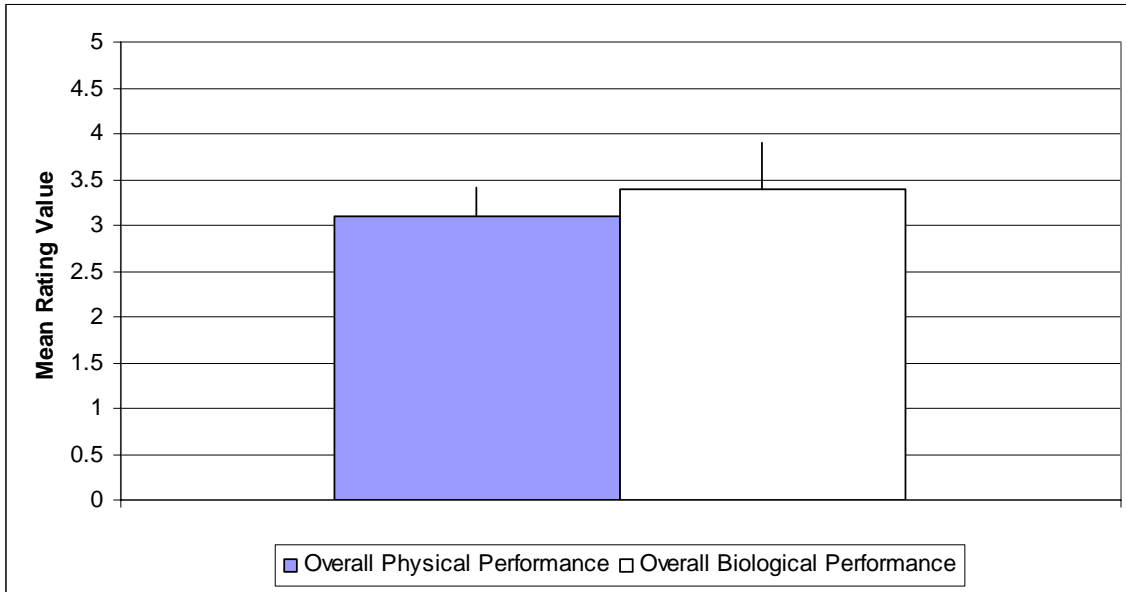
The physical and biological performance was evaluated for the 5 structures within Reach 2 (Table 5). The pooled mean physical performance for all structure types was $3.1 \pm .32$, while the pooled mean biological performance for all structure types was 3.4 ± 0.5 (Figure 4). The 5 structures were divided into 2 separate structure categories comprised of lateral debris deflector (n=2) and lateral deflectors (n=3). A summary of the physical and biological performance for each structure type is illustrated in Figure 5. Tables and figures referenced within this section can be viewed in Appendix III – Fish Creek Reach 2.

Figure 4. Summary of performance ratings across all structure types on Fish Creek Reach 2 (\pm one standard deviation).

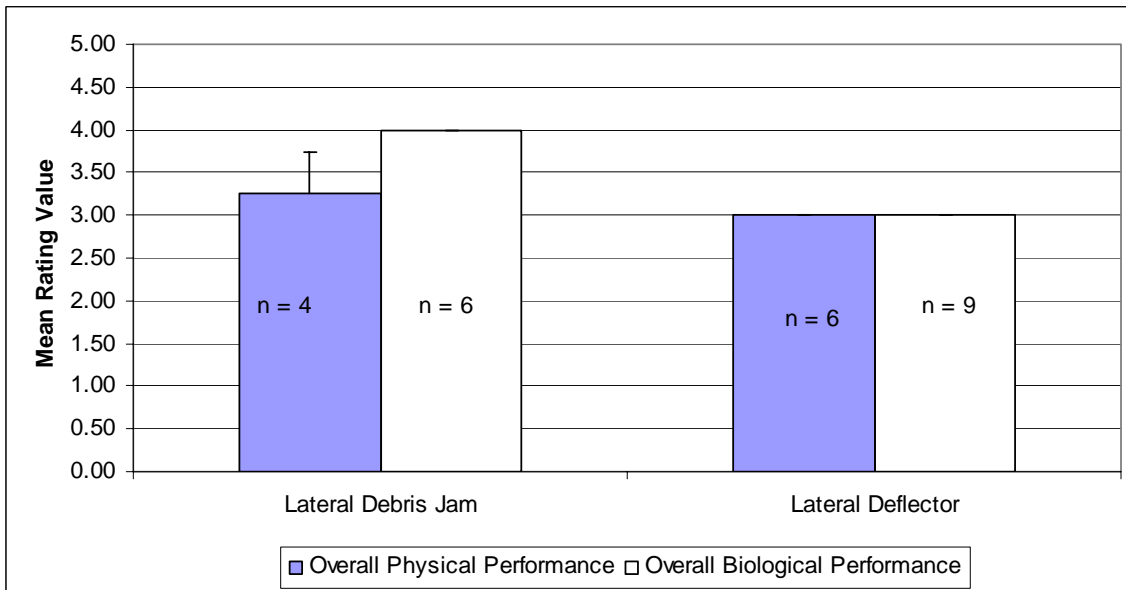
Figure 5. Summary of performance ratings for individual structures on Fish Creek Reach 2 (\pm one standard deviation).

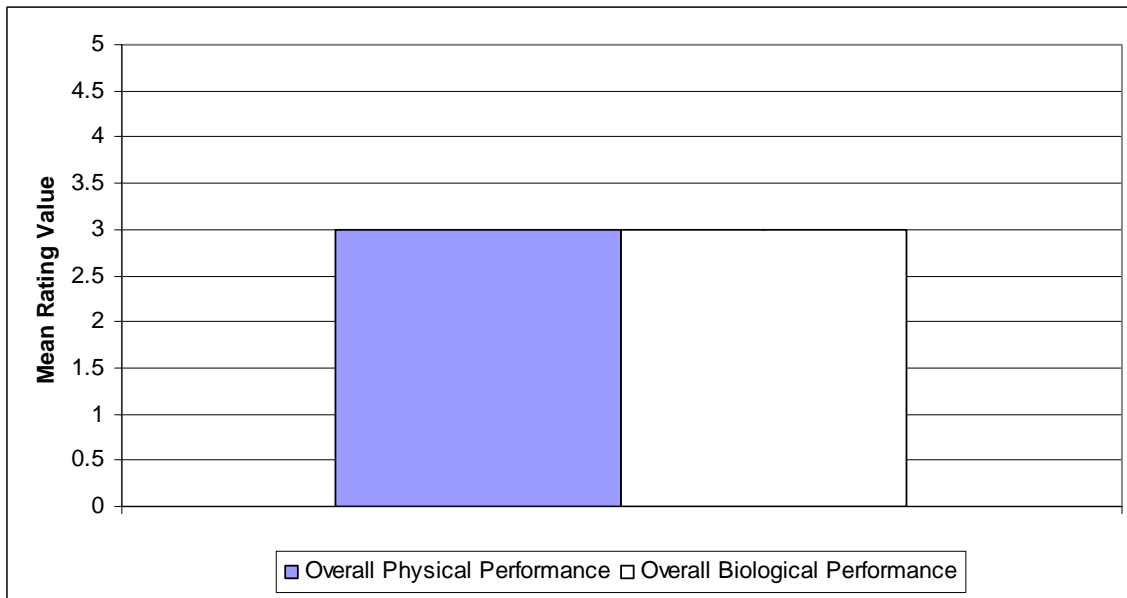
A total of 2 structures located within Reach 3 were evaluated for physical and biological performance (Table 6). The pooled mean physical performance and biological performance for all structure types were both the same at 3 ± 0 (Figure 6). The 2 structures were triangular deflector (n=1) and single cover log (n=1). In addition, a plateau arch culvert that had replaced a hanging culvert was inspected and found to be functioning well. A summary of the physical and biological performance for each structure type is illustrated by Figure 7. Tables and figures referenced within this section can be viewed in Appendix IV – Fish Creek Reach 3.

Figure 6. Summary of performance ratings across all structure types on Fish Creek Reach 3 (\pm one standard deviation).

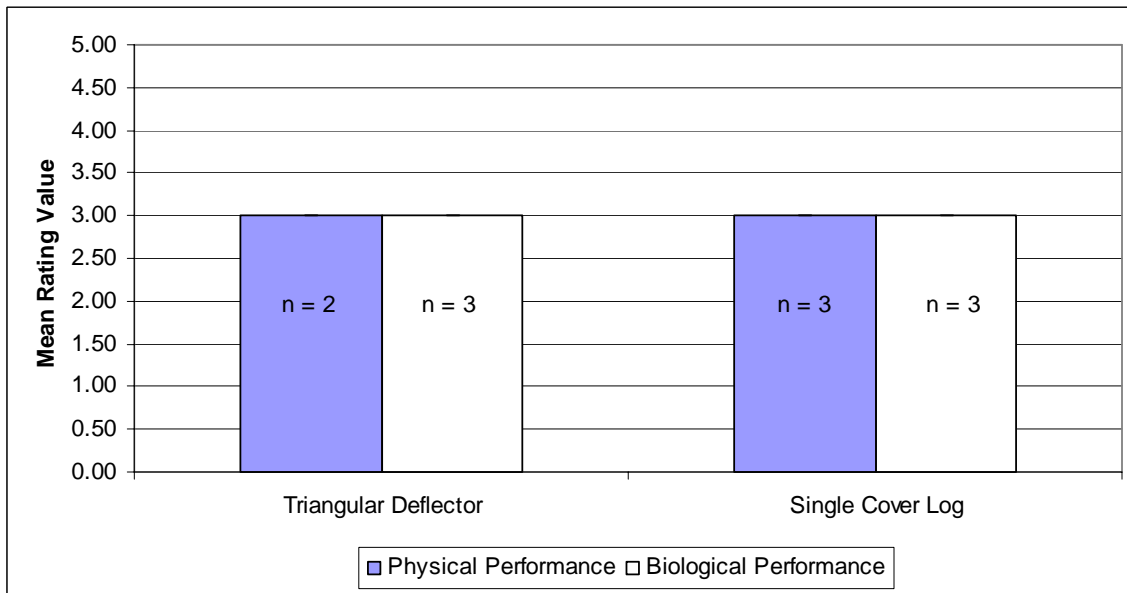
Figure 7. Summary of performance ratings for individual structures on Fish Creek Reach 3 (\pm one standard deviation).

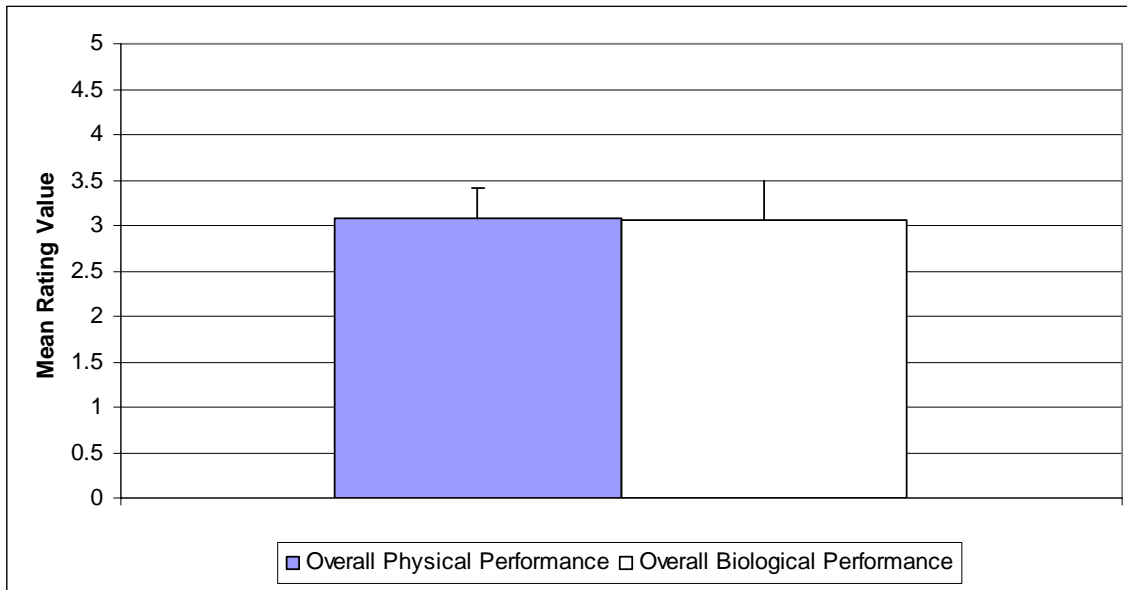
A total of 23 structures located within Reach 5 were evaluated for physical and biological performance (Table 8). The pooled mean physical performance for all structure types was $3.1 \pm .34$, while the pooled mean biological performance for all structure types was 3.1 ± 0.42 (Figure 10). The 23 structures were triangular deflector (n=3), lateral deflector (n=3), opposing single log deflectors (n=1), lateral debris jam (n=5), triple log deflector (n=3), debris catcher (n=2), single cover log (n=1), boulder cluster (n=4). A summary of the physical and biological performance for each structure type is illustrated by Figure 11. Tables and figures referenced within this section can be viewed in Appendix VI – Corkscrew Creek Reach 5.

Figure 10. Summary of performance ratings across all structure types on Corkscrew Creek Reach 5 (\pm one standard deviation).

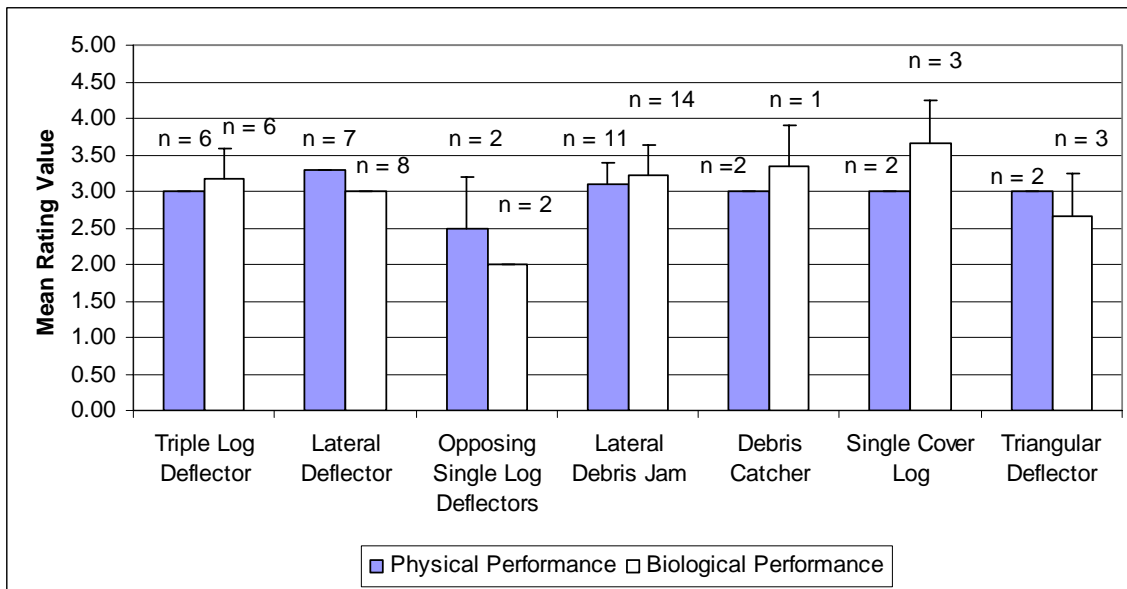
Figure 11. Summary of performance ratings for individual structures on Corkscrew Creek Reach 5 (\pm one standard deviation).

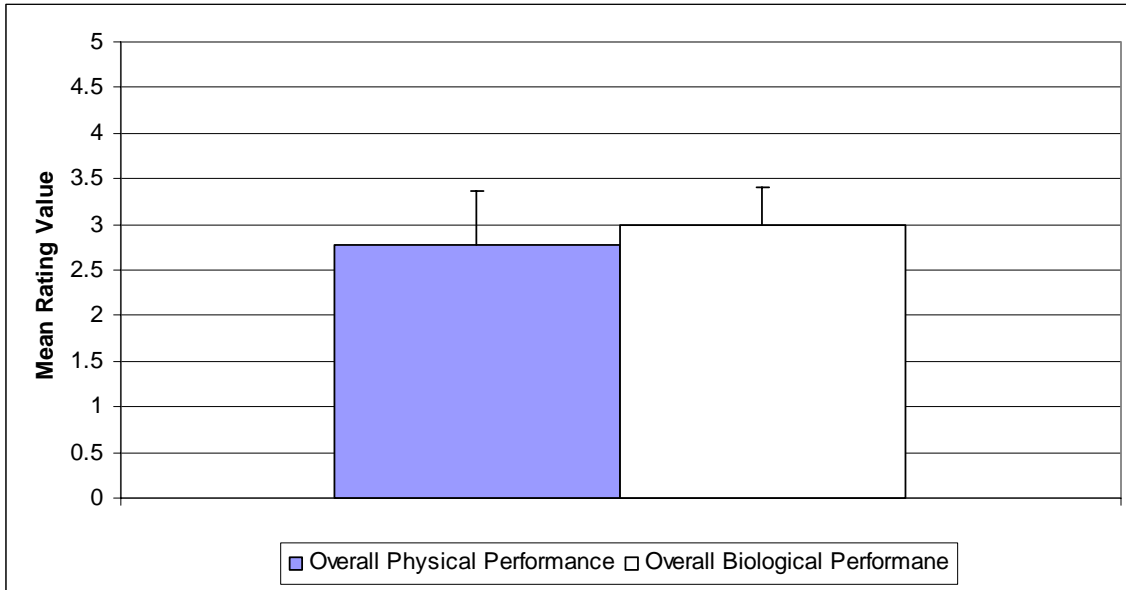
A total of 5 structures located within Reach 6 were evaluated for physical and biological performance (Table 9). The pooled mean physical performance for all structure types was $2.8 \pm .60$, while the pooled mean biological performance for all structure types was $3 \pm .40$ (Figure 12). The 5 structures were triple log deflector (n=1) and triangular deflector (n=4). A summary of the physical and biological performance for each structure type is illustrated in Figure 13. Tables and figures referenced within this section can be viewed in Appendix VII – Corkscrew Creek Reach 6.

Figure 12. Summary of performance ratings across all structure types on Corkscrew Creek Reach 6 (\pm one standard deviation).

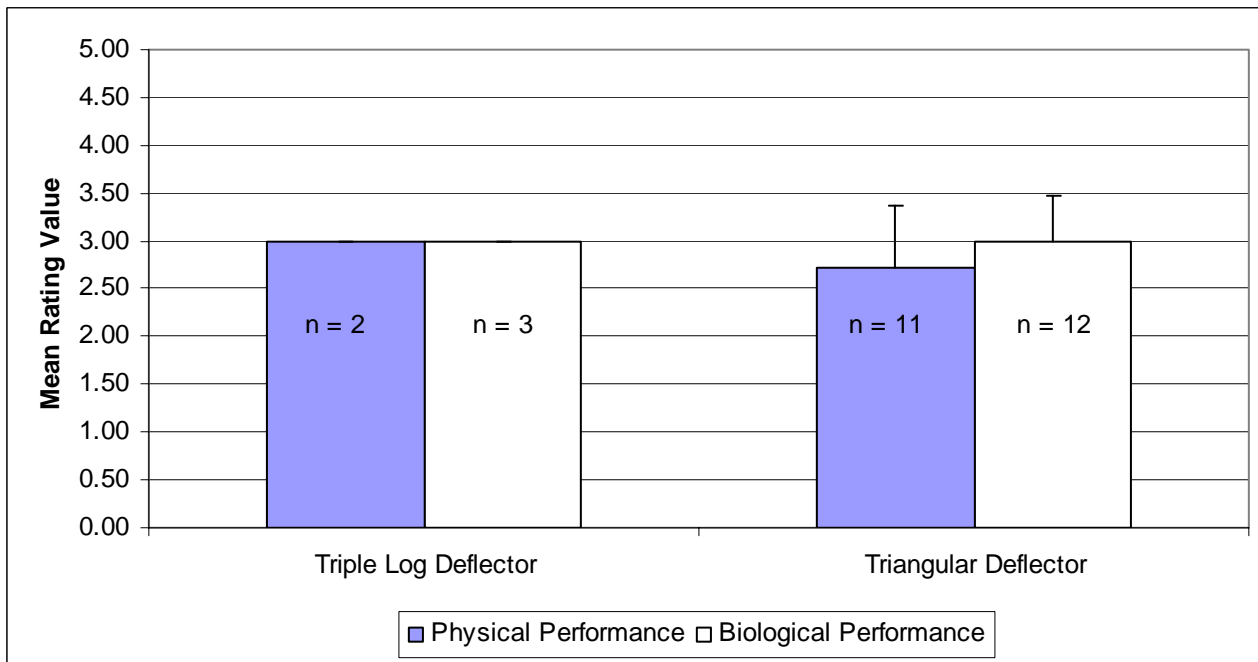
Figure 13. Summary of performance ratings for individual structures on Corkscrew Creek Reach 6 (\pm one standard deviation).

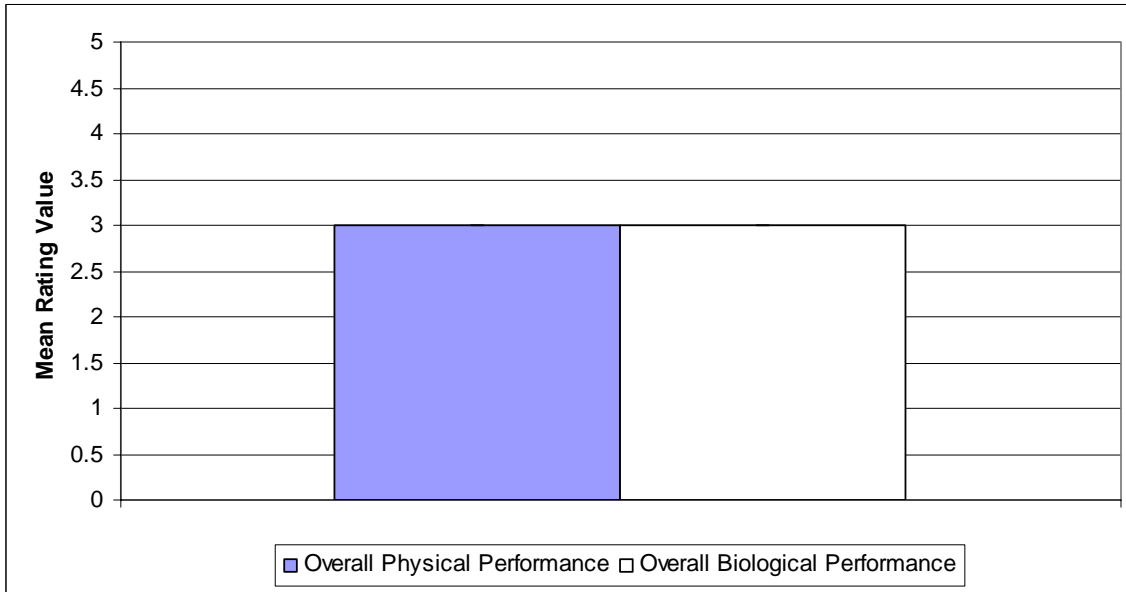
A total of 5 structures located within Reach 6 were evaluated for physical and biological performance (Table 10). The pooled mean physical performance and biological performance for all structure types was both the same at 3 ± 0 (Figure 14). The 5 structures were triple log deflector (n=1), debris catcher (n=2), single cover log (n=1) and log-boulder reef (n=1). A summary of the physical and biological performance for each structure type is illustrated in Figure 15. Tables and figures referenced within this section can be viewed in Appendix VIII – Stony Creek Reach 2.

Figure 14. Summary of performance ratings across all structure types on Stony Creek Reach 2 (\pm one standard deviation).

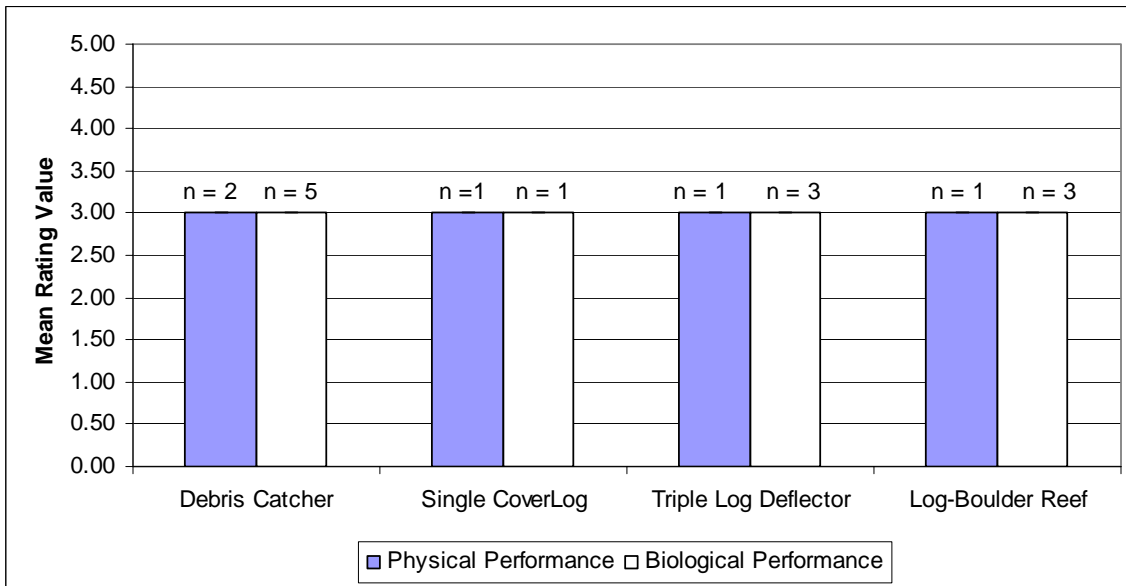
Figure 15. Summary of performance ratings for individual structures on Stony Creek Reach 2 (\pm one standard deviation).
